U. S. PUBLIC LAND SURVEY MONUMENT RECORD

SECTION 27 T 15 N, R 7 W, TOWN OF Shelby

LA CROSSE COUNTY

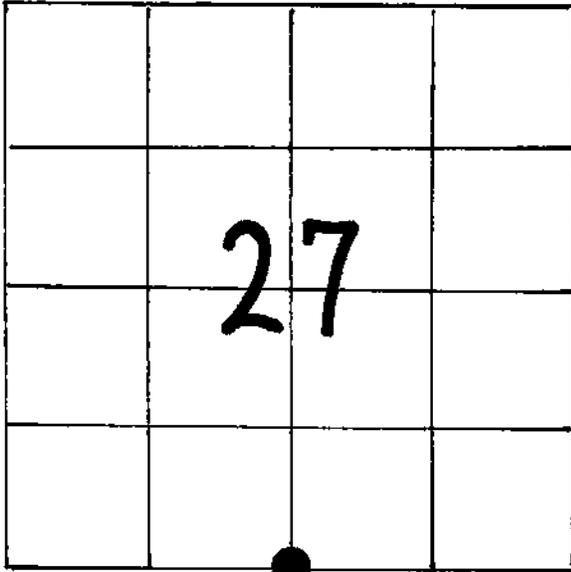
LOCATION OF LANDMARK

The corner was destroyed during highway construction. I set a 1 $\frac{1}{4}$ " iron pipe at the corner. (See my narrative on the voided 9/25/86 tie sheet for information on how this corner was located in '86.)

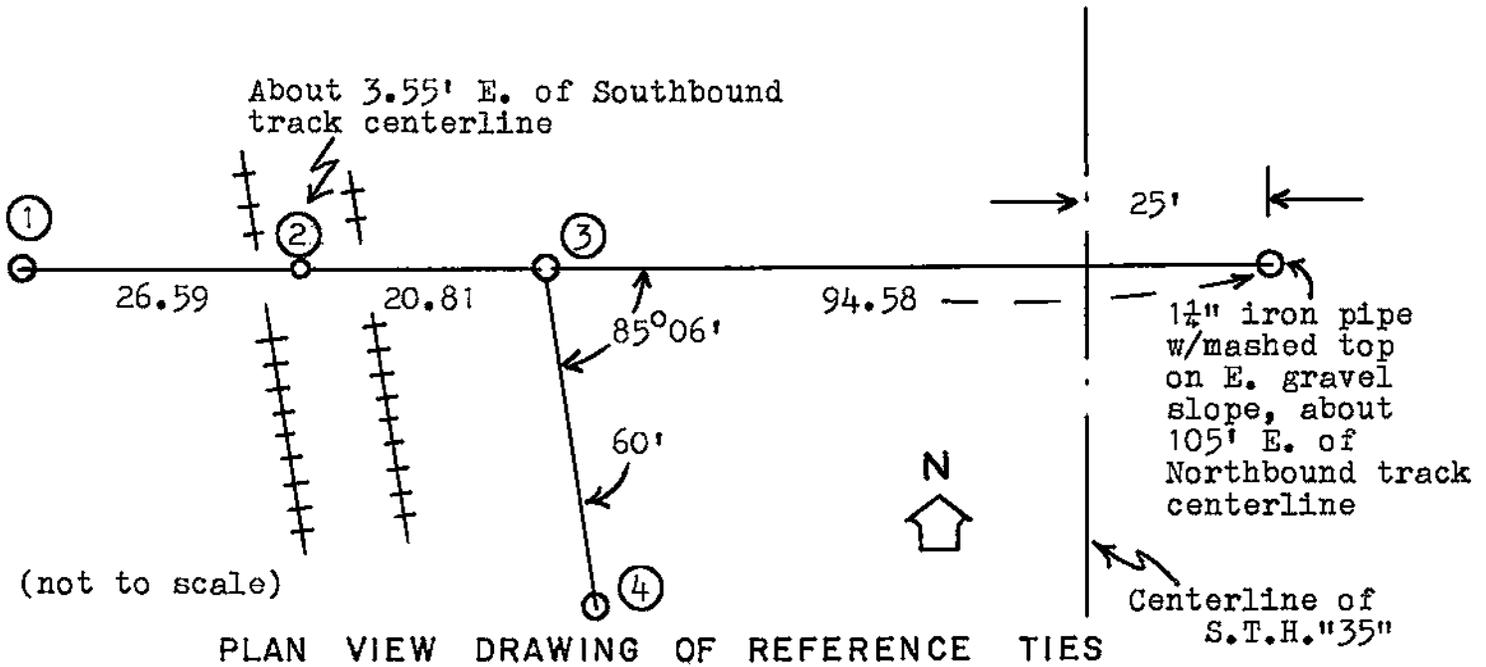
NO	DESCRIPTION	BEARING	DISTANCE
1	Reset D.O.T. rebar on line	-----	141.98
2	Set a P.K. nail on line on a RR tie	-----	115.39
3	Set a 1/2"x18" rebar on line	-----	94.58
4	Set a 1/2"x18" rebar	-----	-----

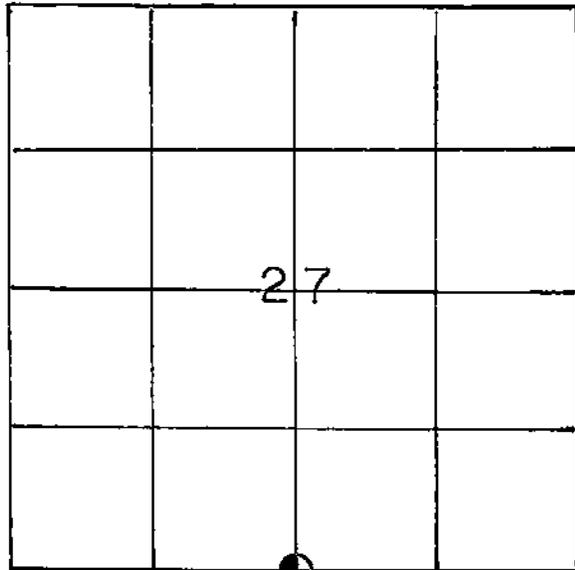
LOCATION OF LANDMARK

The Corps of Engineers surveyors set a monument at this corner as shown on their map dated 1936. I searched for but could not find a monument. Further investigation would indicate that a final monument was never set. On January 19, 1934, the Corps notes show that their surveyors set a point at the corner and tied it off but did not set a permanent monument because of road construction. Their notes say that the corner falls in the pavement. On June 4 of this year, Jim Mueller of the Corps St. Paul office said that he thought that the monument was never set and that the 1936 map had a drafting error. I therefore set the corner at a location so as to best fit the original government survey and the Corps resurvey. (continued below)

The Corps surveyors set this 1/4 corner 2640 feet East of the SW corner as per the original government notes. I set the corner on line with the section corners and 2640 feet East of the Southwest corner so as to fit previous surveys. This leaves the South line of the SE1/4 short, but I believe that this 1/2 mile was short in distance due to errors in chaining coming down off the cliff and bluff. In my computations it appears that the Corps corner was about 104 feet East of the center of the Northbound track. My final corner falls about 105 feet East of the center of the Northbound track. If the corner fell out in the hayfield, the Corps surveyors would probably have set a monument and buried it as they did at the South 1/4 Corner of Section 34. I set a railroad spike at the final corner.

Ray Hengel set a 1" pipe at the corner which I do not agree with. Clayton Solberg calls for the corner as being in the centerline of the road. I do not agree with that location either.

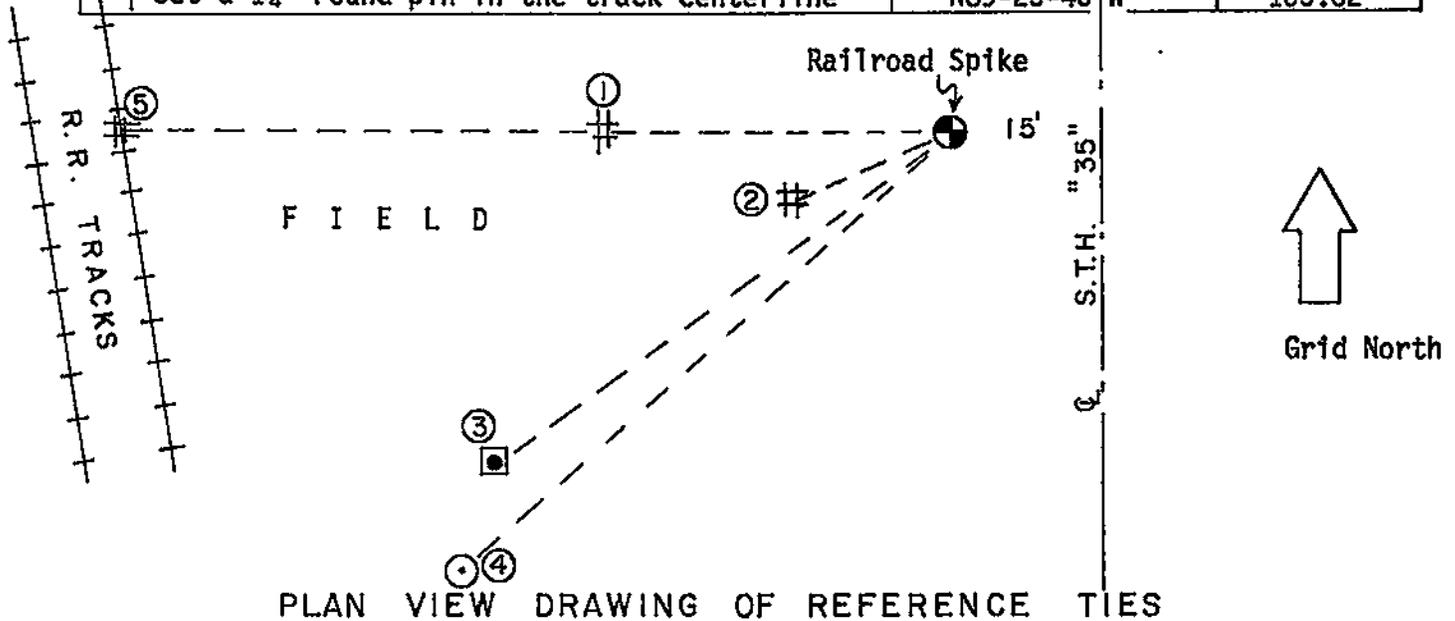
NO	DESCRIPTION	Grid	Ground
		BEARING	DISTANCE
1	Set a 1" iron pipe	N89-23-18W	35.00
2	Hengel's iron pipe	S81-55-08W	16.18
3	USGS marker with witness sign	S29-56-08W	109.33
4	D.O.T. Berntsen control marker	S21-20-03W	198.62
5	Set a 1 1/4" round pin in the track centerline	N89-25-46 W	105.02

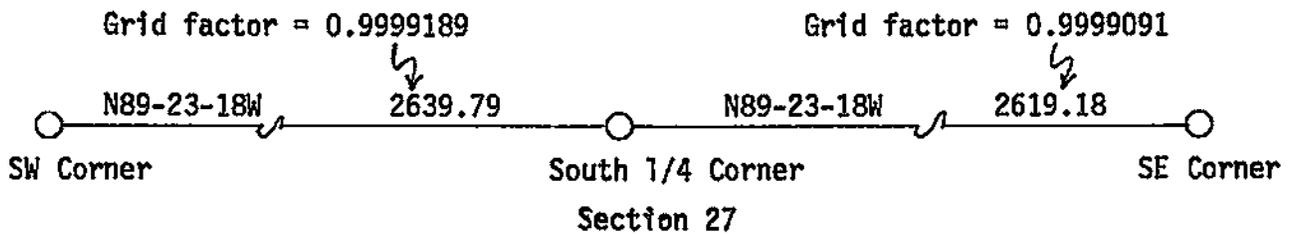
MAP SHOWING DISTANCE AND DIRECTION TO OTHER PUBLIC LAND SURVEY CORNERS USED FOR REESTABLISHING THE CORNER

Grid bearings to the nearest second and grid distances to the nearest hundredth.
