U. S. PUBLIC LAND SURVEY MONUMENT RECORD

SECTION 12 T 16 N, R 7 W, City Onalaska TOWN OF MEDARY

LA CROSSE COUNTY

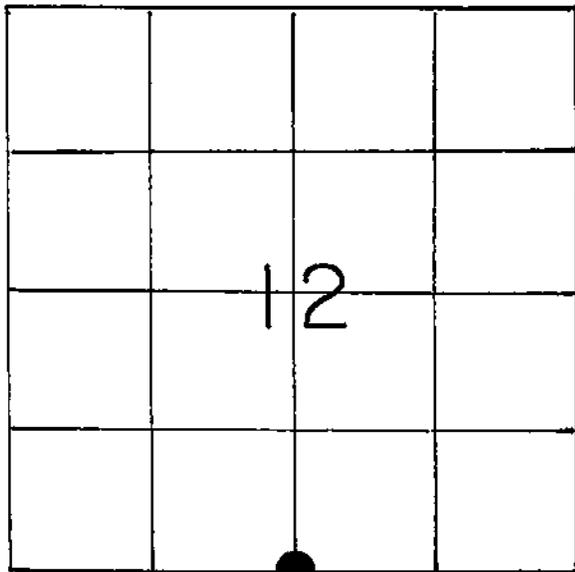
LOCATION OF LANDMARK

I found a railroad spike at the corner. I removed the spike and excavated a 7" square hole to a depth of 7" where I found a 1 1/2" pipe. The pavement was new and the digging hard, so I drove a 5/8"x18" reinforcing rod into the center of the pipe. The rod is the corner. I also set nails with plastic caps 1' East and 1' South of the corner. The corner is 0.02' North and 0.02' East of the railroad spike. To the West of the corner at a distance of 33 feet I found a pipe bent over. This 1/4 corner location has been used as the corner in previous surveys done by Clayton Connell.

I found the iron rod (rebar) inside of an iron pipe. The rod was bent so I removed it. An iron pipe is now at the corner.

The corner of record was knocked out during construction. We set a P.K. nail & cap at the corner.

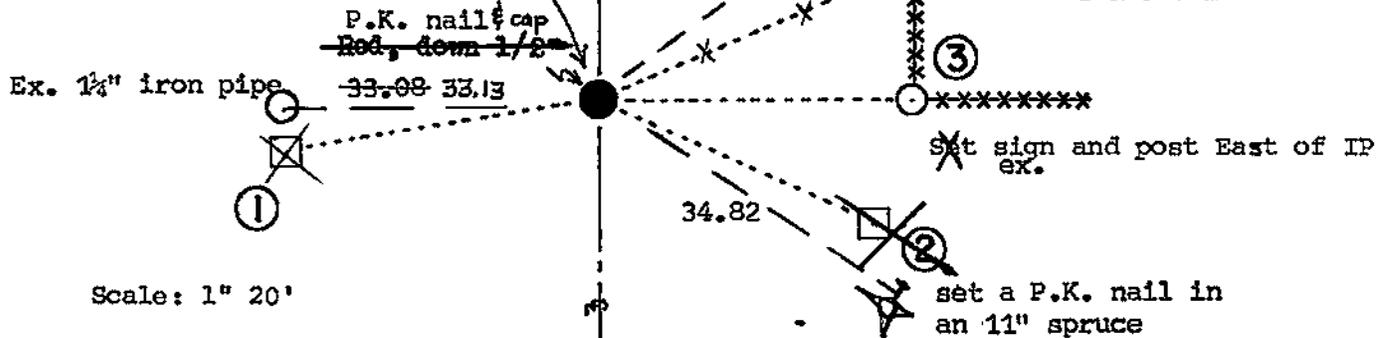
RECORD OF DURABLE WITNESS MONUMENTS

NO	DESCRIPTION	BEARING	DISTANCE
1	CENTER OF EXISTING UTILITY BOX @ BASE	---	33'
2	CENTER OF EXISTING UTILITY BOX	---	31.6'
3	EXISTING 2" IRON PIPE (1 1/8")	EAST	33'
4	OVERGROWN NAIL IN 8 1/2" NORWAY PINE, UNBLAZED	N60°E ±	34.94'

set new nail in NW side of Norway (10 1/2")

(0.66' South is an ex. nail and cap)
Existing 2" iron pipe at the corner
(22.66' E-SE is a "hole" in the "T"
on the center of a water shutoff cap)

Note: 25.74' to the East of the P.K. is a hydrant
