U. S. PUBLIC LAND SURVEY MONUMENT RECORD

SECTION 34 T 17 N, R 6 W, ~~TOWN~~ OF VILLAGE OF WEST SALEM
LA CROSSE COUNTY

SECTION 4 T 16 N, R 6 W, ^{VILLAGE} TOWN OF WEST SALEM

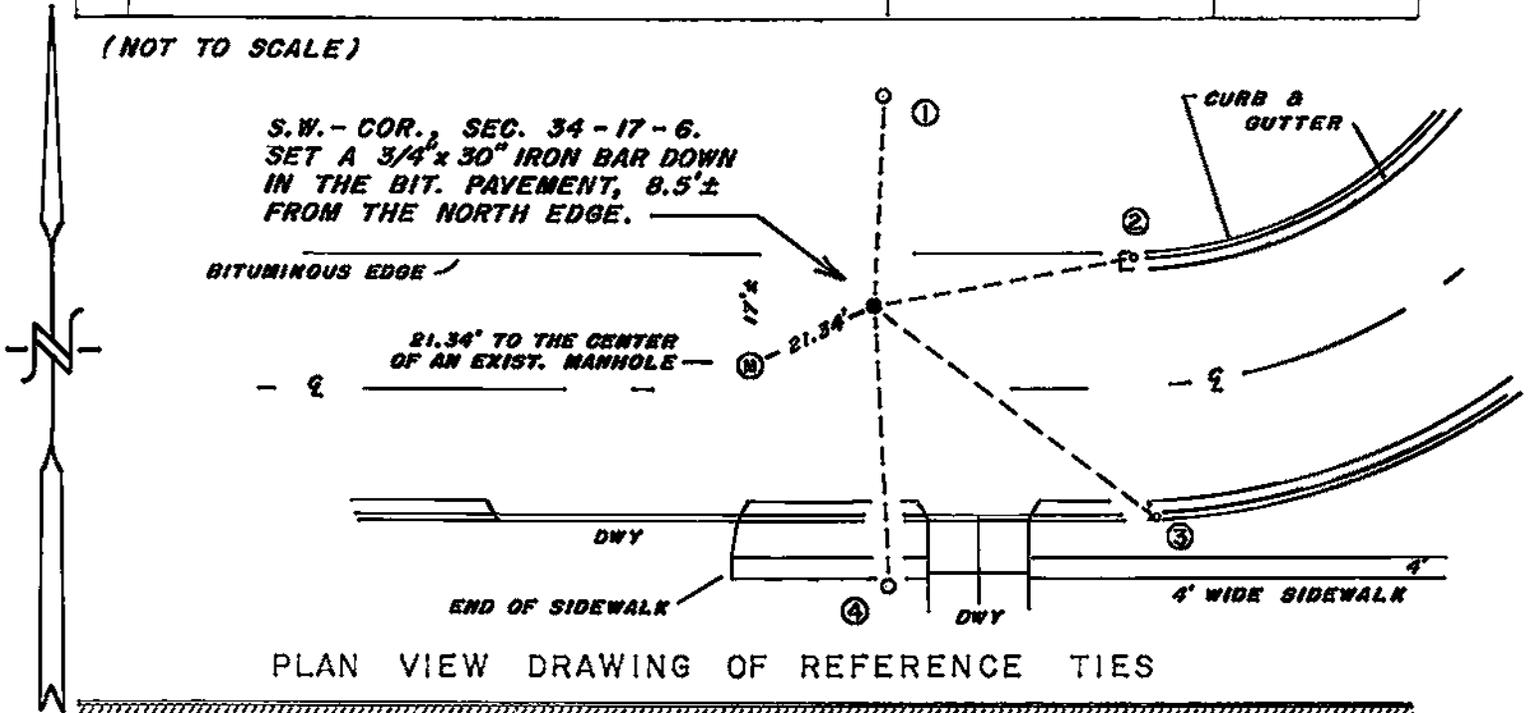
The monument at this corner was knocked out during the reconstruction of "16" last year. I reset the corner with an iron bar.

I do not agree with the mag nail set by Maxwell. This nail is $S71^{\circ}24'E$, 0.08 feet from my iron bar.

NO	DESCRIPTION	BEARING	DISTANCE
1	RESET AN EXISTING 1-1/4" O.D. IRON PIPE (FOUND BENT)	NORTHERLY ±	32.86 FT.
2	SET A DRILL HOLE ON TOP OF CURB, 2' EAST OF END	EASTERLY ±	41.57 FT.
3	SET A DRILL HOLE ON TOP OF CURB, 1' EAST OF JOINT	S. EASTERLY ±	55.41 FT.
4	EX. 1-1/4" O.D. IRON PIPE 5-1/2" BACK OF SIDEWALK	SOUTHERLY ±	43.85 FT.

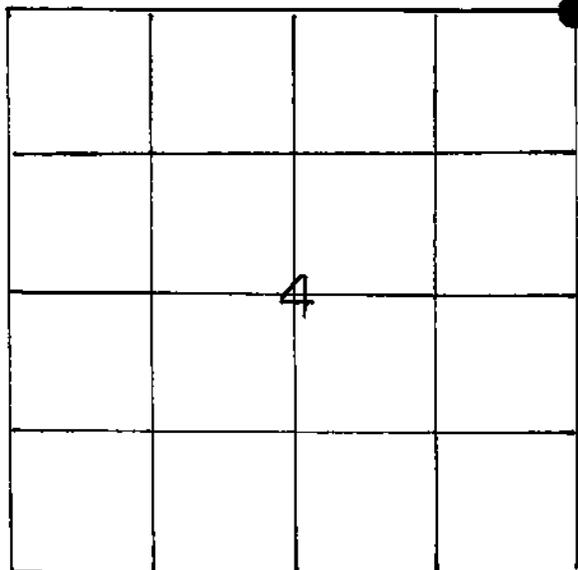
LOCATION OF LANDMARK

This corner caused me a lot of problems as my research showed that it had at least four possible locations. The Village maps show it to be in the centerline of Garland Street. Ken Carlson set a 3/4" iron bar at the corner in the Spring of 1979. He noted at least two possible corner locations. James Allen shows a corner in May of 1966 that would have been about 10.7' South of Carlson's corner. In 1981 Greg Hofmeister disagreed with Carlson's corner and set an iron pipe. A Clayton Solberg map of October, 1962, shows a corner that would differ from Carlson and Hofmeister. I reset the corner at Carlson's location. His iron bar was destroyed during street construc-

tion. Lenschow used this location in 1972 as did Lampman in March of 1985. The Plats of Salem Territory and First Addition to Salem Territory are tied to my corner location. Therefore my corner agrees with Carlson, Lenschow, Pederson, Chalsma, and DOT hwy. maps dating back to 1935. Allen, Hofmeister, and Clayton Solberg disagree with this final location. I discussed this problem with Ray Pelishek, and he agrees with my location too. Also, Dick Berg and Rob Lampman agree with my final corner. My traversing and computations indicate to me that my corner best fits the original government corner location.
