## U. S. PUBLIC LAND SURVEY MONUMENT RECORD

SECTION 18 T 17 N, R 7 W, TOWN OF ONALASKA

LA CROSSE COUNTY

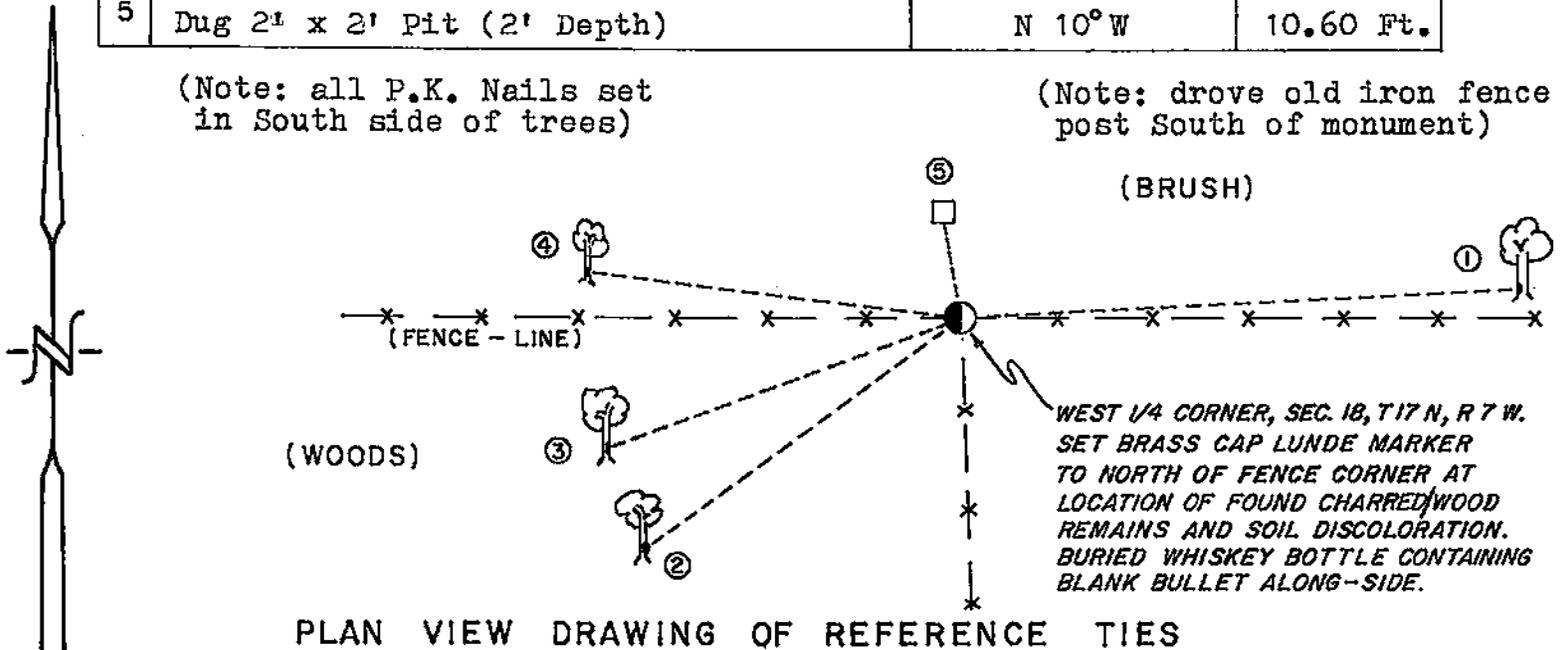
PLAN VIEW DRAWING OF REFERENCE TIES

NO	DESCRIPTION	MAGNETIC	
		BEARING	DISTANCE
1	Set P.K. Nail in 14" Bur Oak (Dbl. Blz)	N 87° E	74.43 Ft.
2	Set P.K. Nail in 9" Jack Oak (Dbl. Blz)	S 54° W	40.70 Ft.
3	Set P.K. Nail in 10" Jack Oak (Dbl. Blz)	S 70° W	39.12 Ft.
4	Set P.K. Nail in 7" Jack Oak (Dbl. Blz)	N 83° W	39.86 Ft.
5	Dug 2' x 2' Pit (2' Depth)	N 10° W	10.60 Ft.

(Note: all P.K. Nails set in South side of trees)

(Note: drove old iron fence post South of monument)
