U. S. PUBLIC LAND SURVEY MONUMENT RECORD

SECTION 31 T 18 N, R 5 W, TOWN OF FARMINGTON

LA CROSSE COUNTY

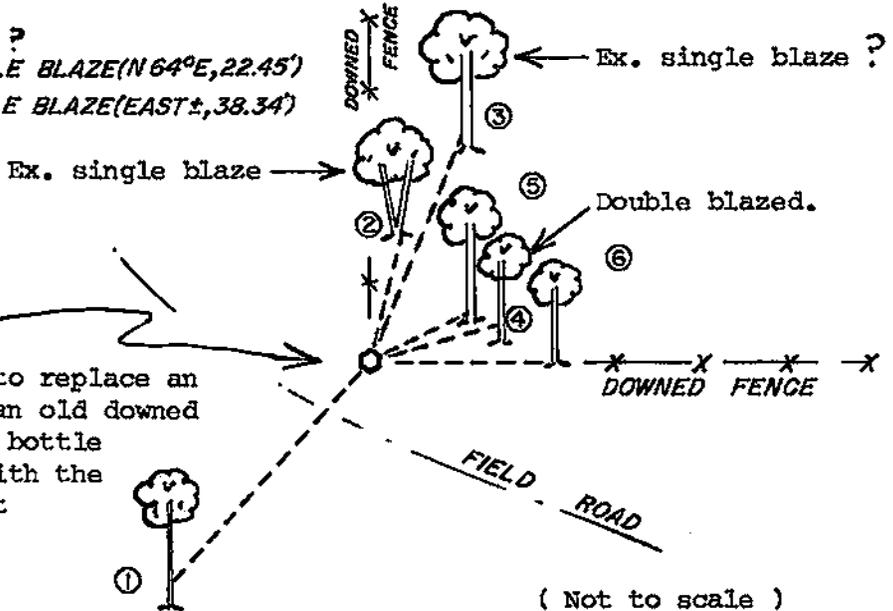
PLAN VIEW DRAWING OF REFERENCE TIES

NO	DESCRIPTION	MAGNETIC	
		BEARING	DISTANCE
1	Set P.K. Nail in NW-side 6" Hickory (unblazed)	S 42° W	62.16 Ft.
2	Set P.K. Nail in SE-side 14" double W. Oak	N 14° E	28.10 Ft.
3	Set P.K. Nail in SE-side 27" Oak (original)?	N 22° E	50.86 Ft.
4	Set P.K. Nail in S.-side 15" W. Oak	N 74° E	27.67 Ft.

⑤ = 22" HICKORY WITH OLD SINGLE BLAZE (N 64° E, 22.45')
 ⑥ = 12" W. OAK (DYING) W/EX. SINGLE BLAZE (EAST ±, 38.34')
 (To center of trees)

N. 1/4-Cor., Sec. 31-18-5.
 Set brass cap Lunde marker to replace an existing bent iron pipe by an old downed fence corner post. Buried a bottle containing a shell casing with the marker and set a sign & post nearby.
