LA CROSSE COUNTY ADMINISTRATIVE CENTER

SPACE NEEDS STUDY

NOVEMBER 22, 2013
FINAL REPORT

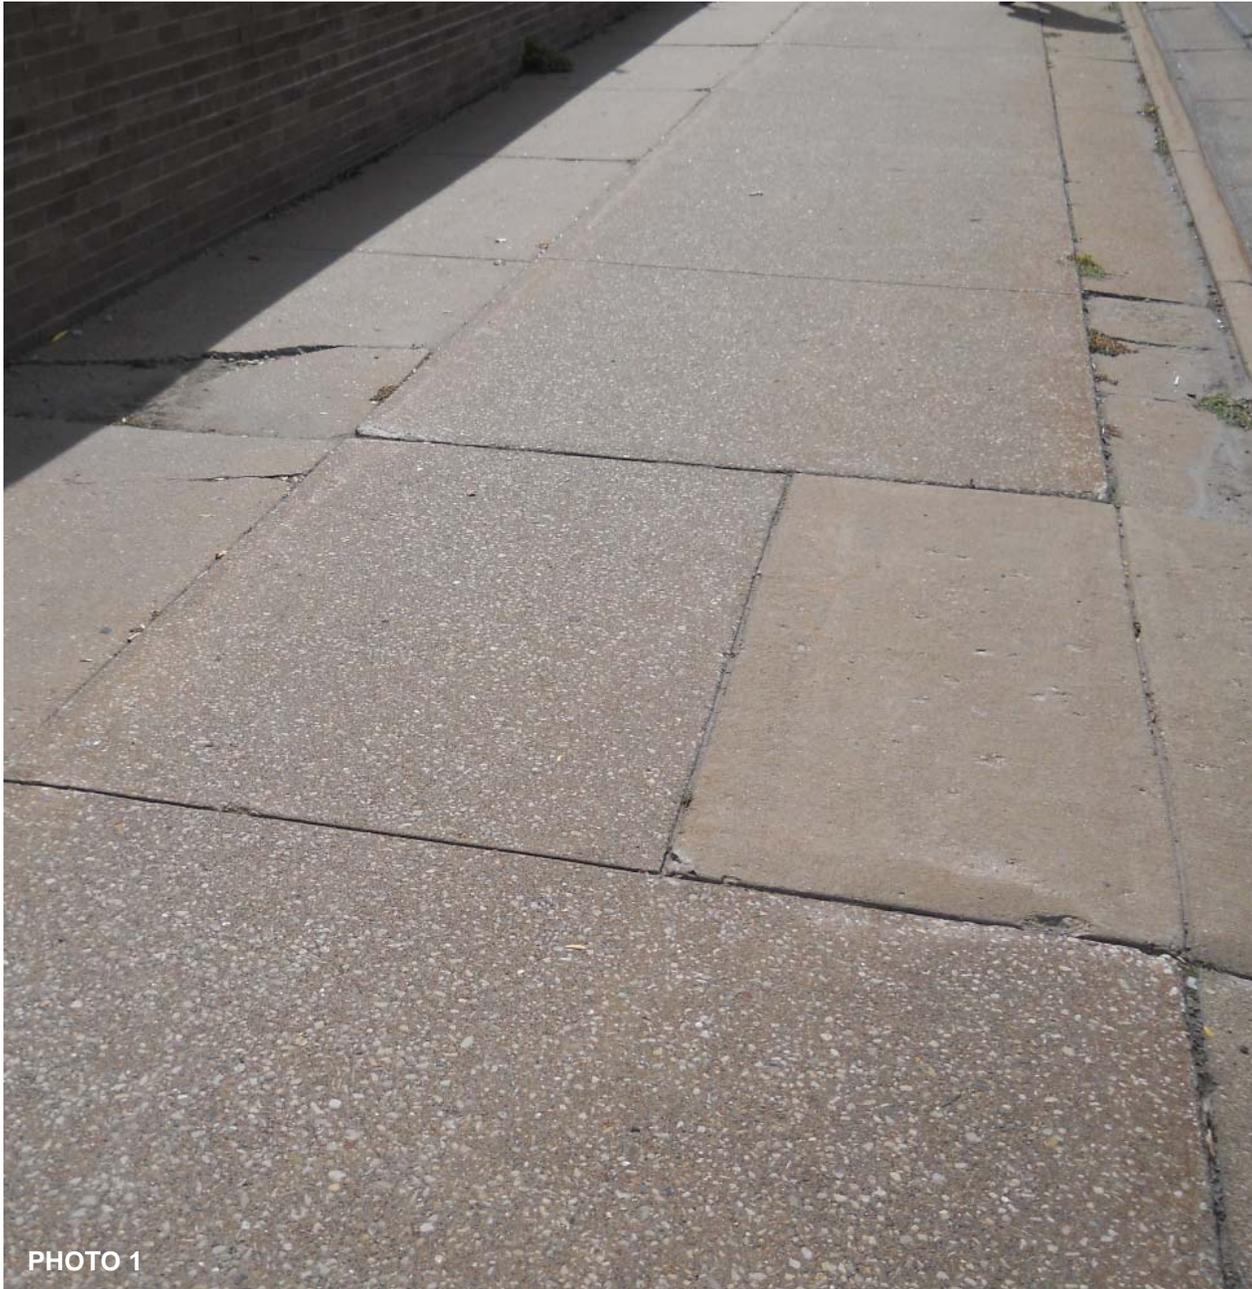
PHOTO 1

There are concrete sidewalks all the way around the building. Overall the sidewalks are in fair to poor condition. Many sections of the sidewalks have been patched in the past and many more are in need of replacement. There are many sections that are cracked and heaved, creating tripping hazards (**Photo 1**). The sidewalks under the canopy areas are a decorative exposed aggregate, colored concrete that has a similar appearance to terrazzo. These decorative sidewalks are in poor condition (**Photo 2**). There are exterior concrete steps/stairs located on the north and west ends near the entrances on those areas of the building. At least one of the aluminum handrails at both of these stairs has been damaged (bent).

Due to the required maintenance work on the building exterior and the site, most of the existing sidewalks and landscaping would most likely be damaged and would need to be replaced. It may be possible to save the majority of the trees or at least be able to relocate the smaller trees to new locations. The damaged tree near the west wall of Building Unit 'B' should be removed. The retaining walls need to be completely removed and new walls built or the grades from the building to the sidewalks changed to eliminate the need for retaining walls. The small site wall on the east side should be removed and not be replaced; this site wall is a trip hazard and does not positively add to the appearance of the landscaping. Most if not all sidewalks should be removed and replaced. Concrete filled steel pipe bollards should be added at the overhead garage doors on the south side of Building Unit 'B' to protect the building from being struck by vehicles if the overhead doors were to remain. The handrails at the exterior steps/stairs should be replaced and updated to meet current building codes.

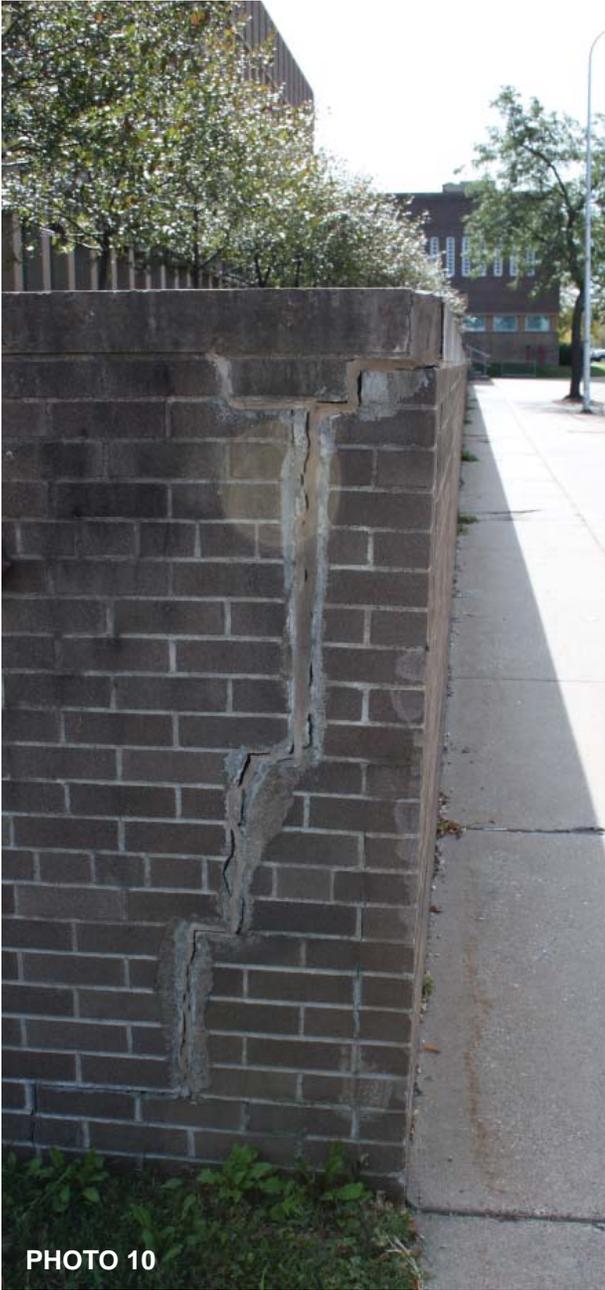
PHOTO 10

north and west has or is presently, undergoing some outward movement. The north wall has had some tie-back anchors installed. It is apparent at the northwest corner that there is outward rotation (**Photo 10**) of the west wall in an ongoing basis. These retaining walls have a significant amount of brick and joint problems due to both movement and moisture (**Photo 11**). The original drawings do not show these walls and the actual construction is unknown. This west wall could be similarly stabilized with tie-backs as a maintenance item. If complete remodeling moves forward, consideration of re-building the walls may be in order.
