**ASBESTOS BUILDING
INSPECTION, BULK SAMPLING
& MANAGEMENT PLANNING**

**La Crosse County
Administrative Building
La Crosse, Wisconsin**

**Project Number AS042342
April 15, 2004**

**La Crosse County Administrative Building
400 North 4th Street
La Crosse, Wisconsin**

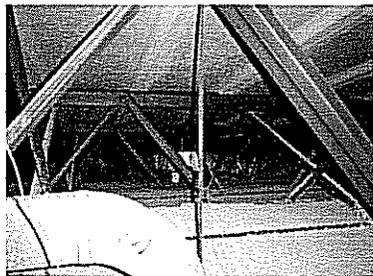
Structural System with Plaster Overspray....

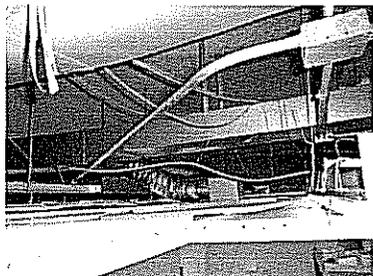
1. Sprayed Fireproofing in Structural Steel & Overspray - This material was found to be extremely friable. This material has been disturbed by trades contractors over the years and fallout from this material is contaminating the top of ceiling tiles, drywall, and plaster ceilings. Fallout from this material is also found on top of ductwork, and inside of the main return air plenums and fire dampers. This material represents an airborne asbestos exposure hazard to building maintenance and contractors working on building systems above suspended ceilings. It has been removed in locations noted as having undergone abatement in this report. This type of material must be removed before disturbance by building renovation activities.

Above Ceiling View of FP Overspray.JPG

1. It is recommended to abate (remove) all structural steel fireproofing materials and related overspray from all surfaces in this building as soon as feasible. This is a major project that may only be cost effective if coupled with a capital improvement remodeling project in the building. Due to the high cost of encapsulation, and the situation that many building air systems are affected by the fireproofing fallout contamination, encapsulation or enclosure are not recommended. These response action (abatement) alternatives would cost up to 80% of the cost of abatement, and the asbestos would still remain. Removal is the best option, with the lowest long term cost.

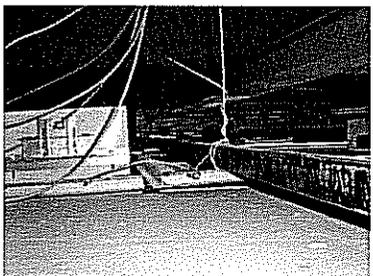
Basement Ceiling with Debris.JPG

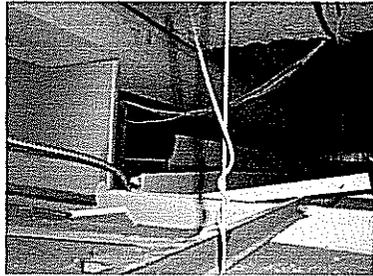
Basement Fireproofing & Debris.JPG

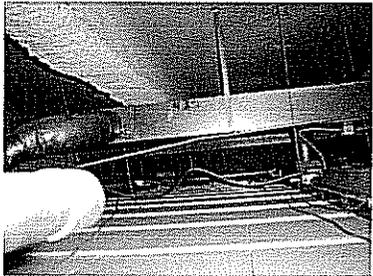
Fireproofing on I-Beam.JPG

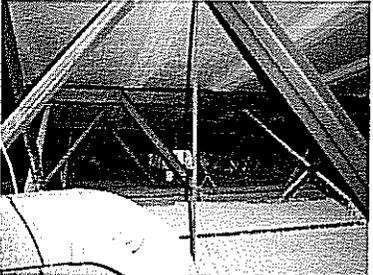
Structural System with Plaster Overspray....
