U. S. PUBLIC LAND SURVEY MONUMENT RECORD

SECTION 12 T 17 N, R 8 W, TOWN OF HOLLAND  
 LA CROSSE COUNTY

SECTION 1 T 17 N, R 8 W, TOWN OF HOLLAND  
 LA CROSSE COUNTY

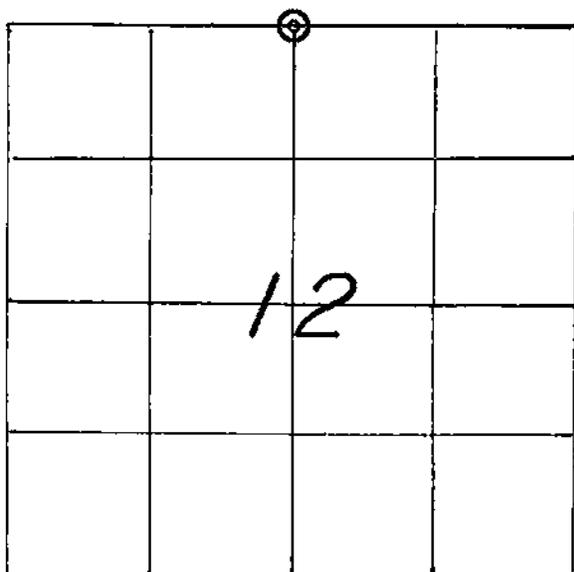
LOCATION OF LANDMARK

The monument at this corner was destroyed during road construction. We set a P.K. nail at the old corner location.

NONE KNOWN.

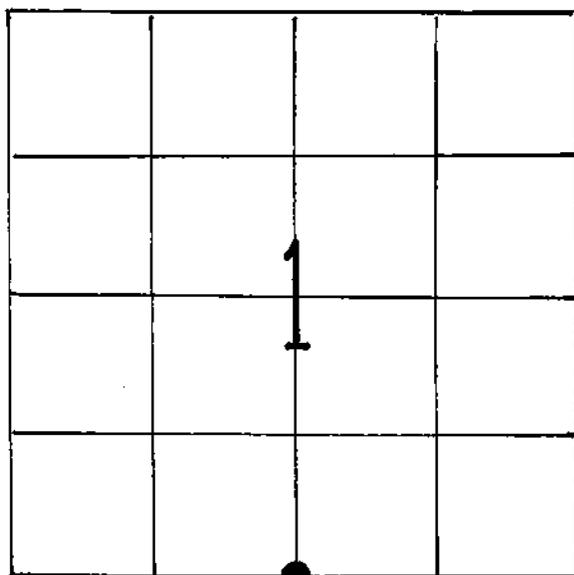
LOCATION OF LANDMARK

I found an iron pipe at the corner that has been used as the corner in numerous previous surveys. I accepted this pipe as the corner by common usage or report. I think that the pipe should have been 12' East and 5' South, but to do so would cause untold legal problems for the public and surrounding landowners. Also, I cannot completely prove that the corner is wrong. Therefore, I accepted the pipe location as the best available evidence, pounded it down, and set 10" of Barntsen top over it.

Note: Ray Pelishek, Phil Scholze, and Bob Chalsma all agree that the existing pipe location should be used.

None known.

10" Barntsen top over existing iron pipe

Fd. a P.K. nail set by the D.O.T. after new construction. The old monuments appear to be under the new pavement.
