U. S. PUBLIC LAND SURVEY MONUMENT RECORD

SECTION 4 T 16 N, R 7 W, ~~TOWN OF~~ CITY OF ONALASKA

LA CROSSE COUNTY

SECTION 9 T 16 N, R 7 W, ^{CITY} ~~TOWN~~- OF Onalaska
LA CROSSE COUNTY

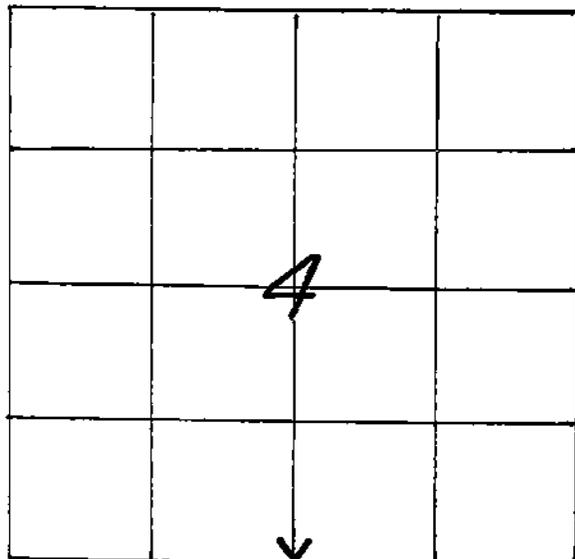
LOCATION OF LANDMARK

COMPUTED LOCATION WITH TIES.

Woodman's P.K. nail from 1988 was knocked out by construction work. This is a very busy intersection, and as such I did not remonument the corner but instead set up tie points around it that can be measured into for corner computation purposes.

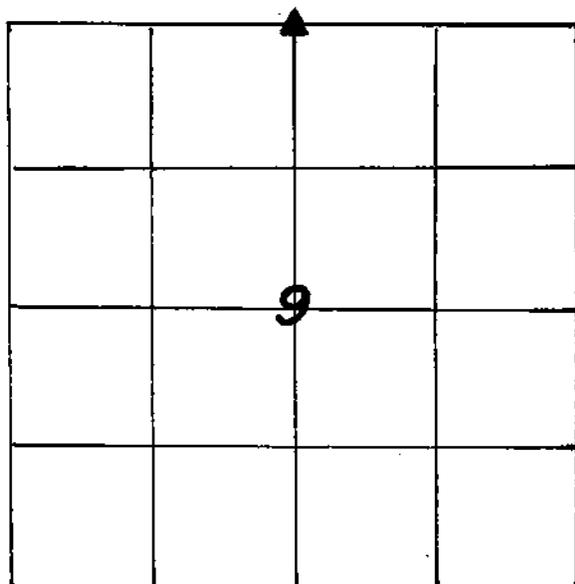
LOCATION OF LANDMARK

This corner, originally, was a stone, which was obliterated. Currently it shows up as a tie on numerous plats and other surveys. Greg Hofmeister, on a C.S.M. for R.B. Schaefer, calls for a broken PK. Nail (1982). Witness testimony from various surveyors, stated that there was a mark on the sewer manhole with a 1" iron pipe 33' south. These were obliterated during reconstruction of the Sand Lake RD.-Main ST. intersection. I reestablished the corner using the ties from the plats and surveys that showed the corner. I set a PK. nail on the north edge of the sanitary manhole on C-C Sand Lake RD.-Main ST., as the best available evidence of the original government corner location.

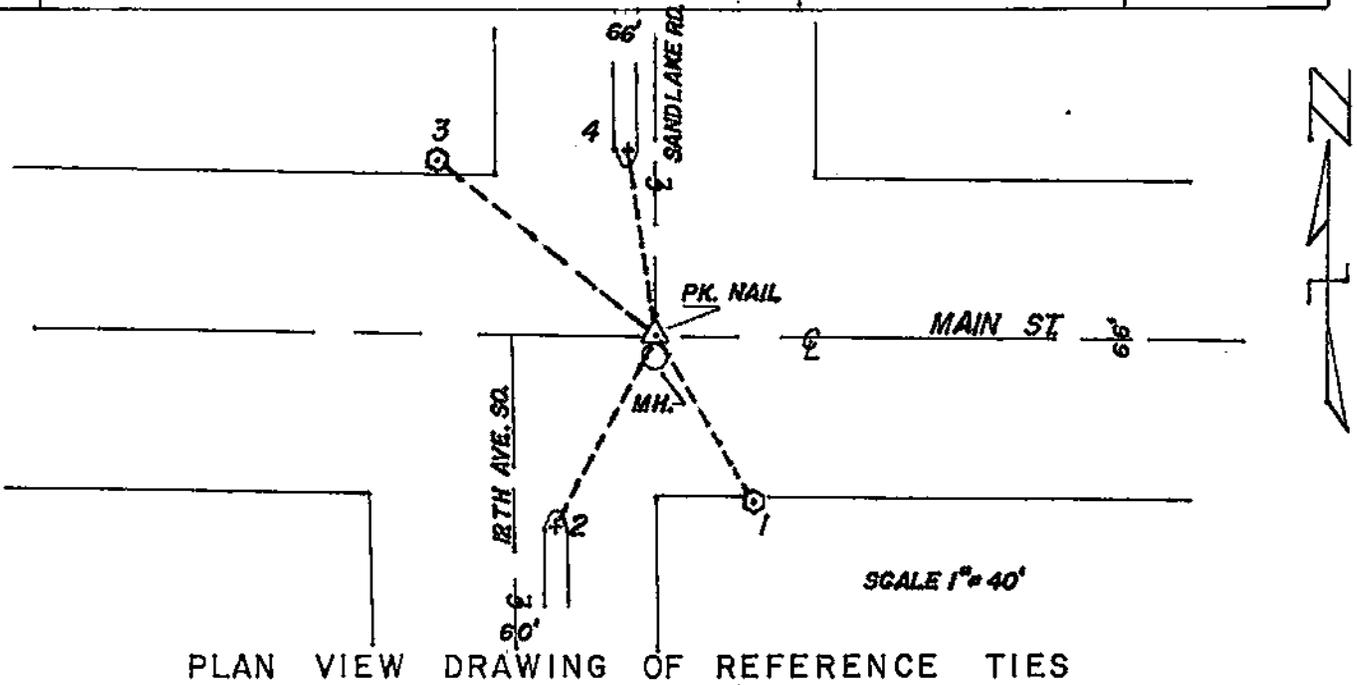
RECORD OF DURABLE WITNESS MONUMENTS

NO	DESCRIPTION	BEARING	DISTANCE
1	Bertsen Monument	S 30° 28' -36" E	40.04'
2	Chisel cross on lane divider	S 28° 18' -57" W	44.35'
3	Bertsen Monument	N51° 35' -03" W	58.63'
4	Chisel cross on lane divider	N09° 06' -15" W	39.34'
