U. S. PUBLIC LAND SURVEY MONUMENT RECORD

SECTION 14 T 15 N, R 6 W, TOWN OF Greenfield

LA CROSSE COUNTY

UNIVERSAL SURVEY MONUMENT FOLLOW-UP & QUALITY EVALUATION

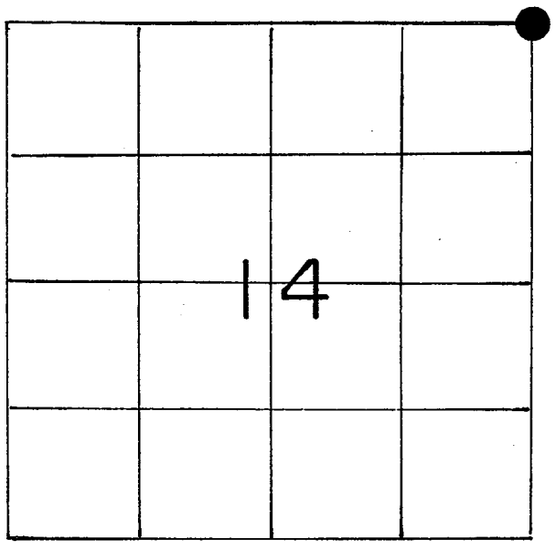
LOCATION OF LANDMARK

Ray Pelishek set a Berntsen marker at the occupied corner in April of 1976. We found that the marker had almost completely dissolved to a combination of powder and small pieces. Ray Pelishek accepted the occupied corner as the best available evidence of the original government corner position. I agree with this. Using his ties, I remonumented the corner with a Lunde marker, buried in a cow lane.

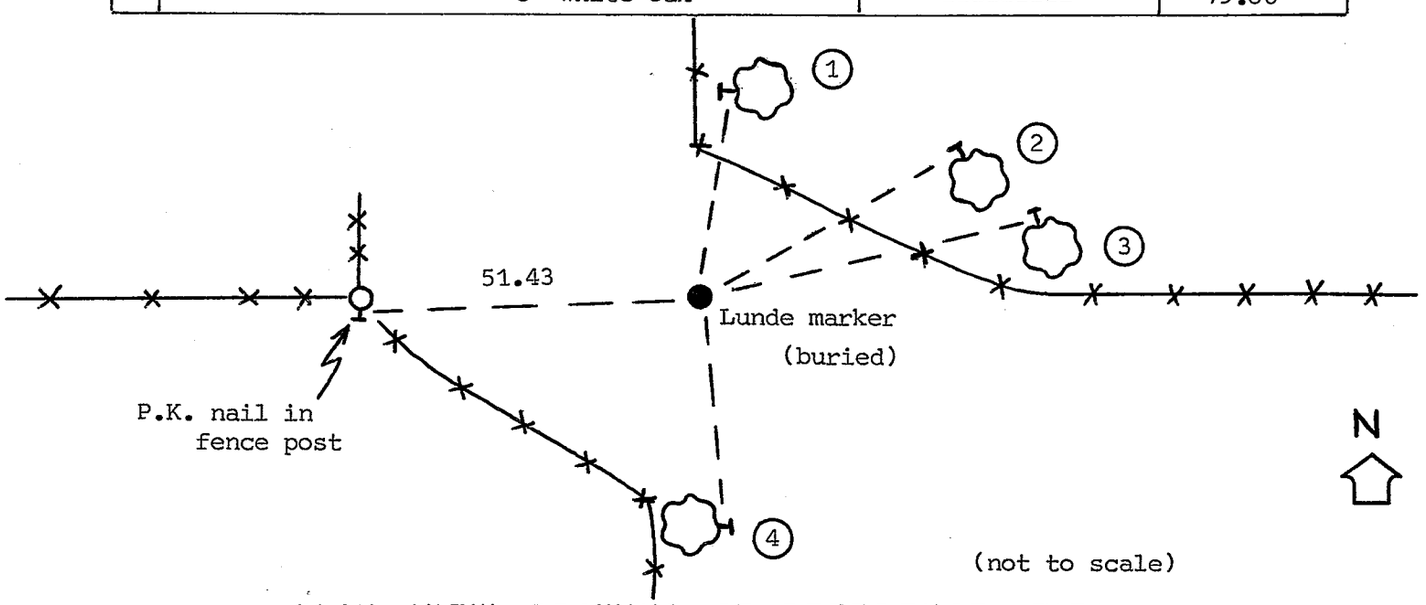
PLAN VIEW DRAWING OF REFERENCE TIES

NO	DESCRIPTION	BEARING	DISTANCE
1	P.K. nail in unblazed 17" hickory	---------	31.12
2	" " " " 16" dying hickory	---------	33.16
3	" " " " 5" tree	---------	44.10
4	" " " " 3' white oak	---------	79.60
