U. S. PUBLIC LAND SURVEY MONUMENT RECORD

SECTION 34 T 17 N, R 6 W, ~~TOWN~~ OF VILLAGE OF WEST SALEM
LA CROSSE COUNTY

SECTION 4 T 16 N, R 6 W, ^{VILLAGE} TOWN OF WEST SALEM

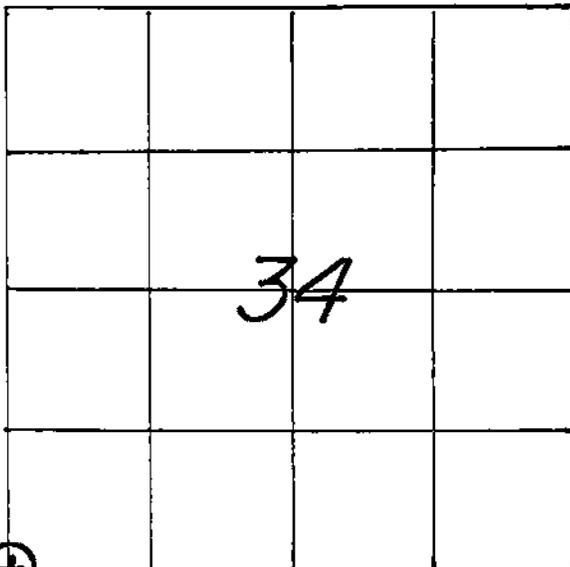
LOCATION OF LANDMARK

The monument at this corner was knocked out during the reconstruction of "16" last year. I reset the corner with an iron bar.

I do not agree with the mag nail set by Maxwell. This nail is $S71^{\circ}24'E$, 0.08 feet from my iron bar.
