U. S. PUBLIC LAND SURVEY MONUMENT RECORD

SECTION 31 T 18 N, R 5 W, TOWN OF FARMINGTON

LA CROSSE COUNTY

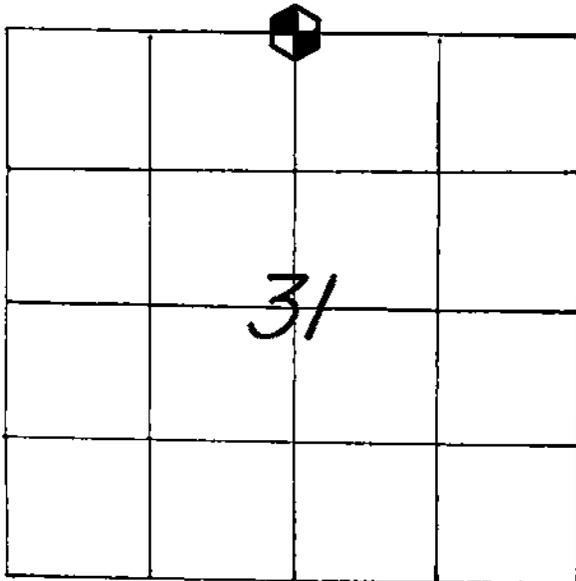
LOCATION OF LANDMARK

BRASS CAP LUNDE MARKER.

Mr. Hemp called and complained that this corner had been bulldozed out. Apparently the operator was working for the landowner to the northwest. Mr. Horstman told me that he thought that this was an accident. I reset the corner at the 1995 position. Of six bearing trees from 1995, only one was still standing!

NONE KNOWN.

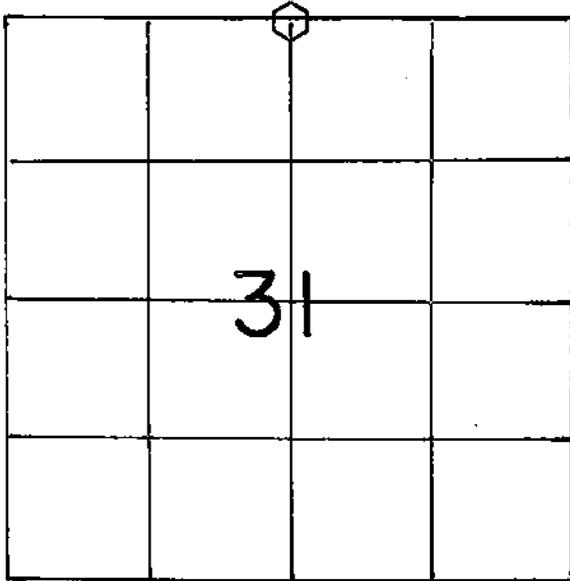
LOCATION OF LANDMARK

Brass cap Lunde marker.

I found an iron pipe at the corner which had been used in previous survey work. I've accepted this pipe as the best available evidence of the original corner position, removed it, and replaced it with a brass capped Lunde marker. The location also fits the occupied location.

None Known.
