LA CROSSE COUNTY ADMINISTRATIVE CENTER

SPACE NEEDS STUDY

NOVEMBER 22, 2013
FINAL REPORT

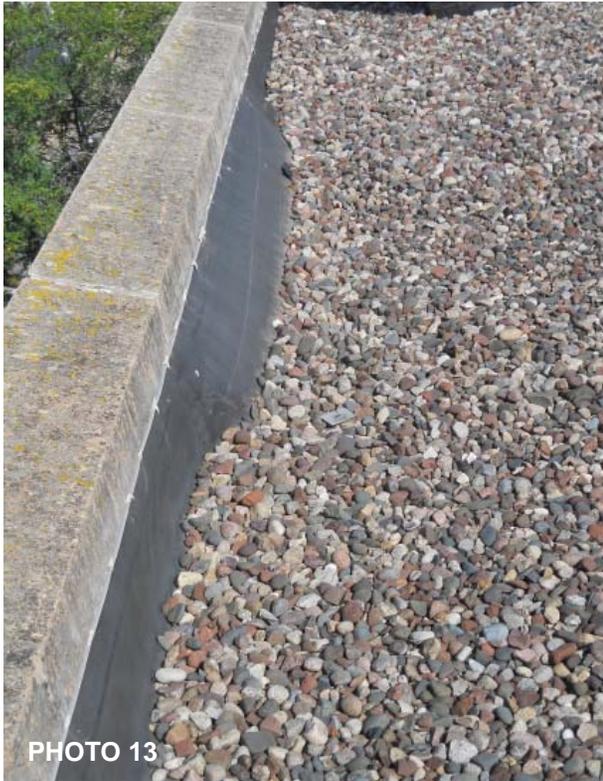
PHOTO 13

The original roof construction at the 2nd story section of Building Unit 'B' was comprised of 2-3/4" thick precast planks, 1-1/2" of rigid insulation, and built-up 6-ply roofing with pitch and gravel. These same systems were used for the roof of the small Mechanical Penthouse Catwalk located on the south end of the 3rd story of Building Unit 'B'. The roof drainage for this area of the building consists of four (4) 4" diameter roof drains. There are no overflow drains or scuppers installed. The base of the communications antenna is located on this roof. The lower roof of Building Unit 'B' was replaced in 1998 with a new Ballasted EPDM membrane roof. It is thought that the original roofing was removed on this roof prior to the new roof being installed. There is currently a section of roof membrane along the west parapet wall where the EPDM has shrunk and is pulling away from the parapet (Photo 13).

We are recommending a full roof replacement for all areas of the building. The existing EPDM roof membranes at the lower Building Unit 'B' roof is 5 years past the end of the warranty and the Building Unit 'A' and upper portion of Building Unit 'B' roof is over almost 20 years past its warranty. As part of this work, the remaining roof areas with the original built-up roofing and insulation should be removed. New tapered roof insulation system should be installed under all roofs to better direct water to the roof drains. There have been issues in

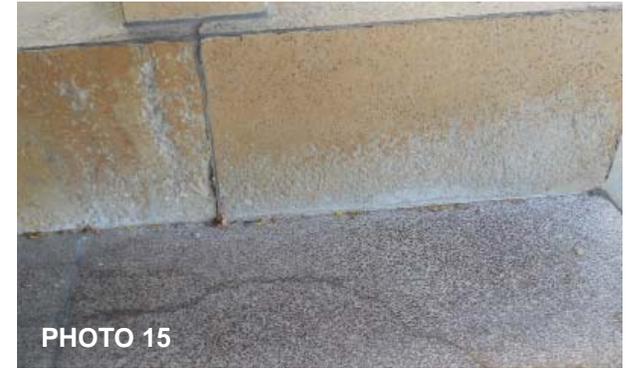
PHOTO 15

The most visible issue with the canopies is the condition of the limestone cladding around the columns and the seat walls. The lower limestone panels have been damaged by weather, abrasion, and deterioration from salts used on the sidewalks (Photo 15). Several panels at both canopies have cracked (Photo 16). Past repairs by recaulking the open joints are failing from continuing movement in the panels. There are some joints/cracks between the panels that are approximately one inch wide (Photo 17). The movement in the panels may be caused by the steel ties/anchors that hold the panels in place rusting away and failing.

Recommend that the existing lower limestone panels be removed so that repairs can be made to the underlying structure and replacement of the anchors that hold the stone panels in place. Details for the top of the seat walls should be modified to allow for better drainage of water and to reduce

the number of joints at the top of the stone panels. New stone panels may be required to replace those that are too severely damaged. We are also recommending that the damaged limestone at the roof edge either be repaired in-place or removed and replaced with new after repairing steel supports as required. To prevent further water intrusion, the sheet metal roof coping/flushing detail should be changed so that sheet metal covers the entire support steel and the top of the stone so as to shed water away from the joint and not rely on joint sealants at this joint. The joint sealant between the concrete roof slab and the stone banding at the ceiling should be removed and replaced. The exposed concrete ceiling should be stripped of the existing paint and either cleaned and left exposed or primed and repainted with a paint system that is recommended for use on exterior concrete.

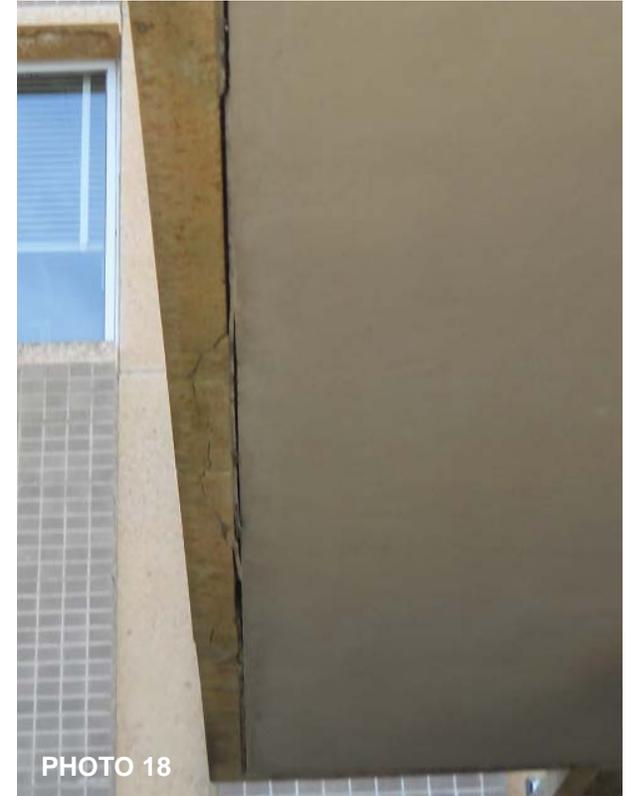
PHOTO 18

This gap allows water to come in contact with the exposed portions of the steel anchor plates that support the stone banding. Joint sealant is used to seal between the exposed steel mangers and the stone panels. This joint sealant is in poor condition and is potentially allowing water into the joint between the stone banding and the steel hangers. There are a couple of sections of the stone banding that have cracked; this may have been caused either by the freeze/thaw action of water that leaked down between the stone and the support steel or by the rusting of the steel supports. There is a possibility that a section of these damaged panels could become complete dislodged from the support steel and fall off the canopy (Photo 18).

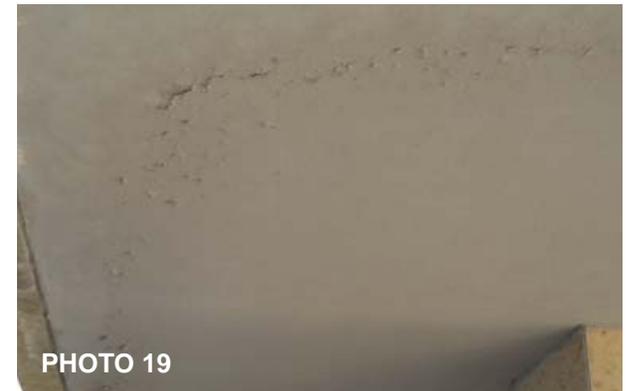
PHOTO 19

As noted above, the exposed ceiling area of the canopies is the underside of the concrete roof slab. The paint is peeling and flaking off the concrete ceiling primarily around the edges of the slab (Photo 19). We suspect that the paint is peeling due to water intrusion into the concrete slab and the joint between the stone roof banding and the concrete slab.

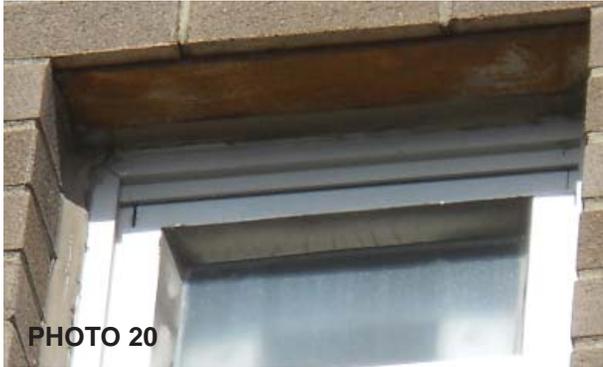
PHOTO 20

the masonry veneer and the window frames and on some windows between the window frames and the glazing. There are some areas where this newer joint sealant is starting to fail (**Photo 20**). There are also indications on several windows that sealant used between the two sheets of glass has completely failed and is melting and running down the interior face of the glass in the air space (**Photo 21**). It was also reported by several building occupants that the window frames will frost up in the winter.

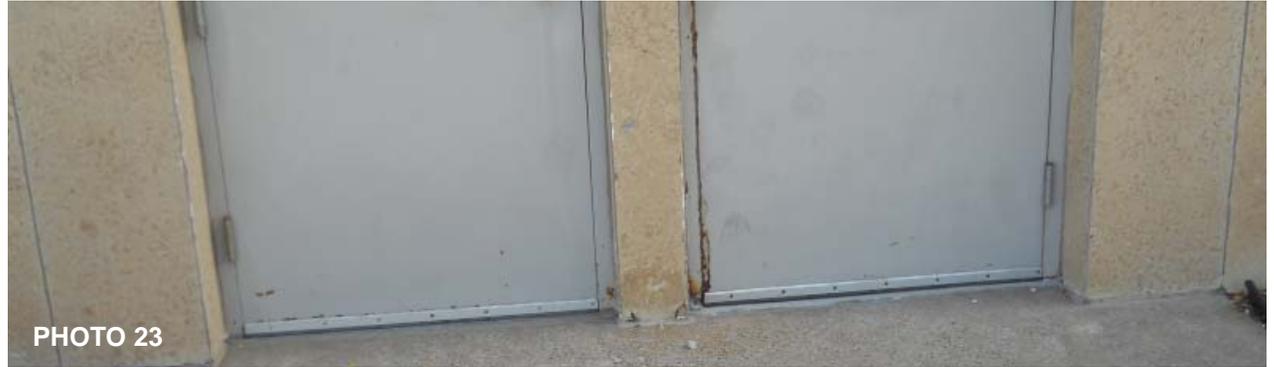
PHOTO 23

The exterior hollow metal doors and frames have areas where they are starting to rust (**Photo 23**). It is unknown if the doors are insulated or if they are insulated, what type of insulation was used. The hardware on these doors appear to be in fair condition but is dated and in most cases appears to be original to the building.

Recommend that all exterior hollow metal doors, frames and door hardware be replaced with new. New doors should be galvanized exterior grade, insulated hollow metal which could be upgraded to Aluminum Storefronts depending on location and use. Door hardware should all be replaced with new so it meets current codes for accessibility and egress.

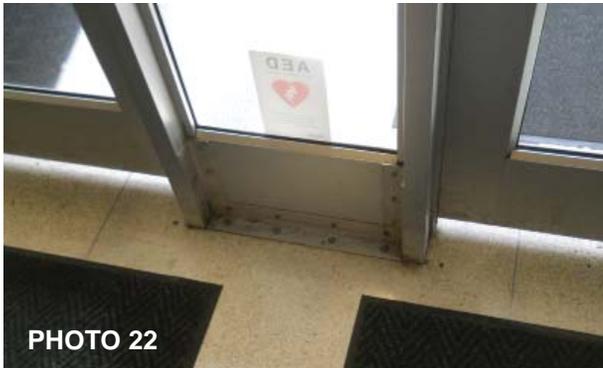
PHOTO 22

It appears that there are some door frames that have required some structural reinforcing/repairs in the past by the addition of aluminum angels screwed to the door frames and the floors. The repairs serve the intended purpose but are unattractive (**Photo 22**). The typical door hardware has exceeded its life expectancy and would require repairs if not replaced. The glazing units are well beyond the life expectancy of modern insulated glazing units; typically the seals will fail and the insulation value of the units will drop significantly. Also, glazing from this era would not include the more modern low-e coatings or have the Shading Coefficient of new glazing.

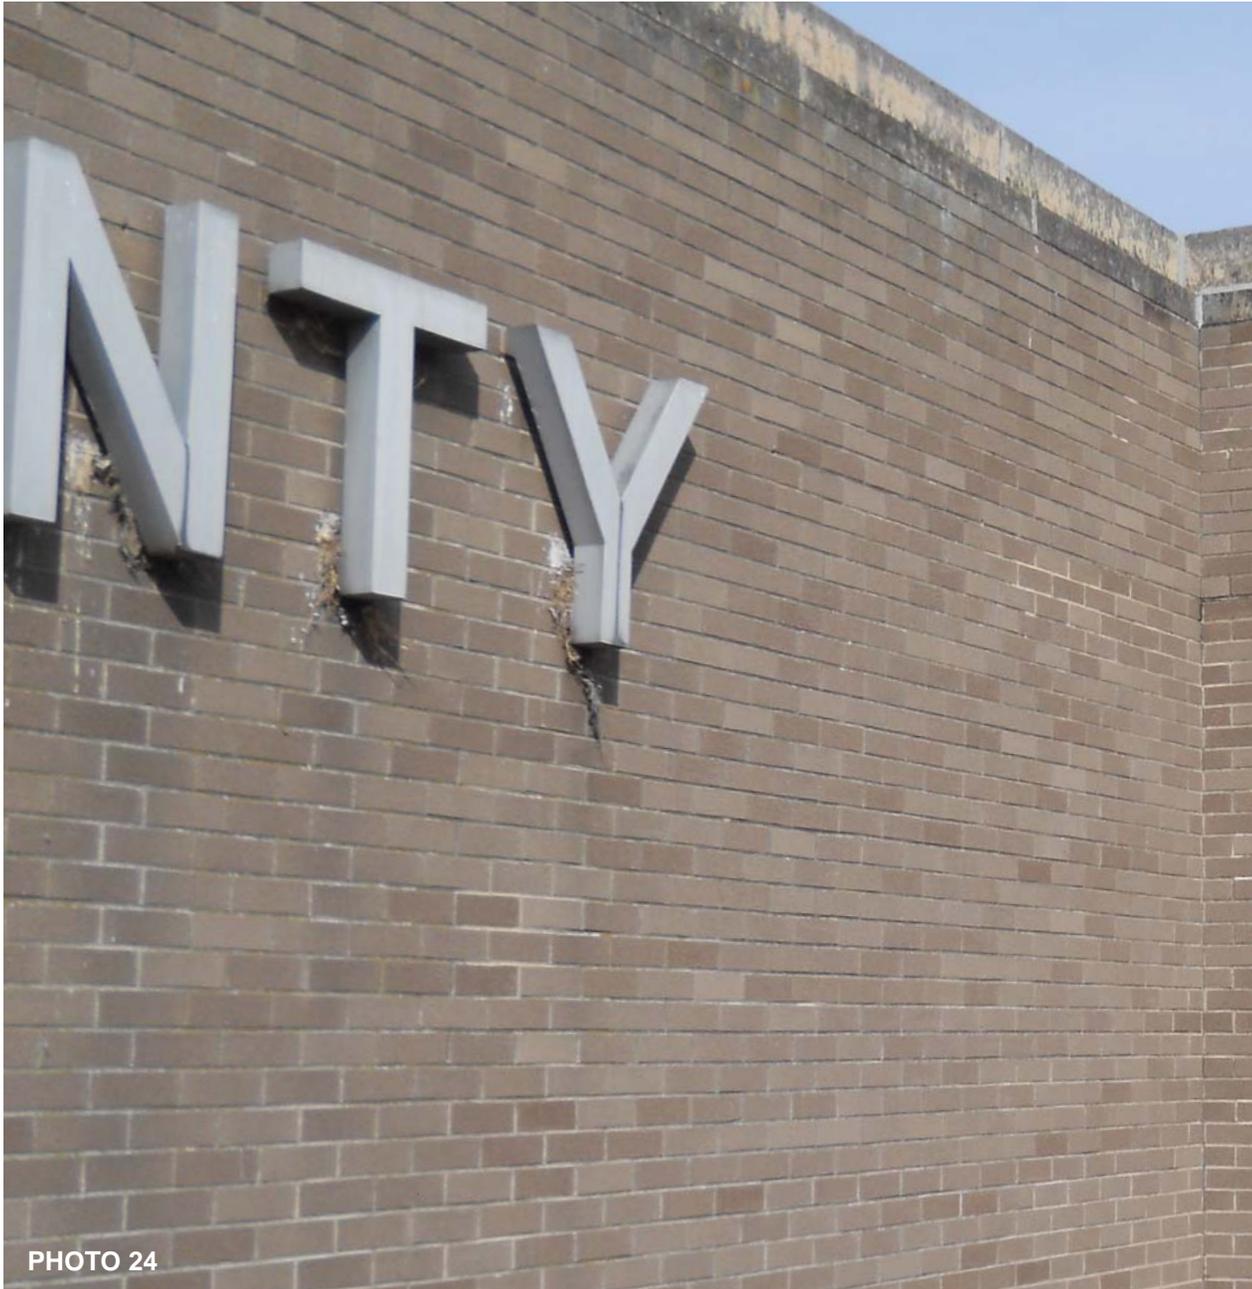
PHOTO 24

There are various types of signage on the building. The aluminum building lettering on the east and west elevations has become nesting grounds for birds (Photo 24). The lettering is installed on standoffs from the face of the building and the back of the letters are hollow/open. Wire screens were added to the backsides of some of the easily reached letters to prevent the nesting but not all letters. There is a

We recommend having a local sign company either replace the building lettering signage with new closed back lettering or

remove and reinstall the current lettering tight to the building. The recessed lit sign on the south building elevation should be removed and the opening filled with brick to match the existing. The placard signs should be replaced so as to coordinate the style of the signs used on the building exterior. Placard signs need to meet ADA requirements.

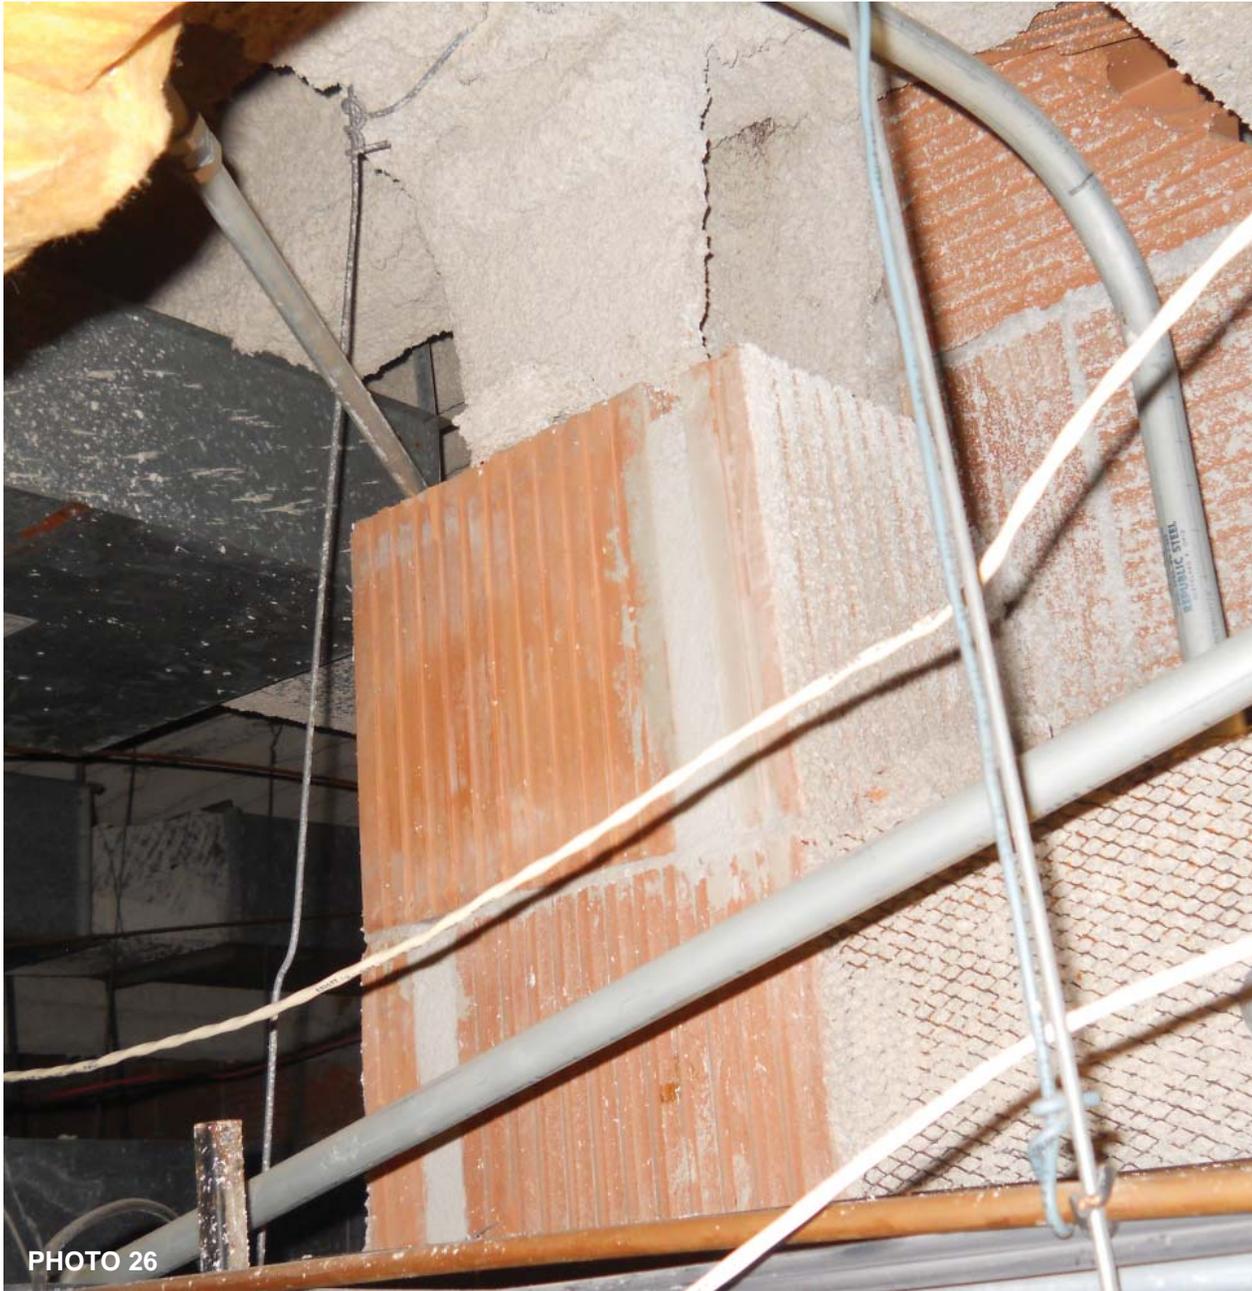
PHOTO 26

The original building documents indicate that the structure for the typical interior partition walls are structural clay tile (hollow core). Expanded metal mesh was installed over the structural clay tile and served as the base for the cement plaster finishes of the walls (Photo 26). Where walls were furred out from the structure behind it, gypsum lath was used as the substrate for the plaster finishes. This appears to be only at the east and west exterior walls of Building Unit 'A'.

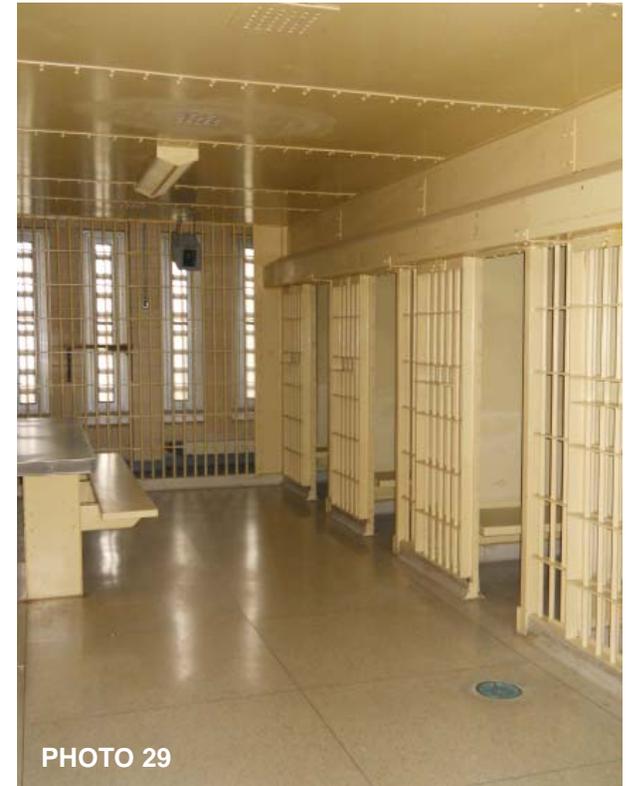
The jail cells in the original 2nd floor jail are constructed of steel panels which were riveted/bolted together. The ceilings throughout the 2nd floor jail are a "security plaster". The ceilings of the jail cells are part of the jail cell system and are also steel plate that is riveted/bolted to the steel walls (Photo 29).

For a change in use of this area of the building would require extensive renovations to change it to viable office space. This would require a complete interior demolition, abatement, and renovation project. All jail systems would need to be removed as well as most interior CMU walls. Mechanical spaces could possibly stay as currently laid out but that is dependent upon new MEP system configurations. Similar to the issues with the structural clay tile (hollow core) is that it is hard to run new

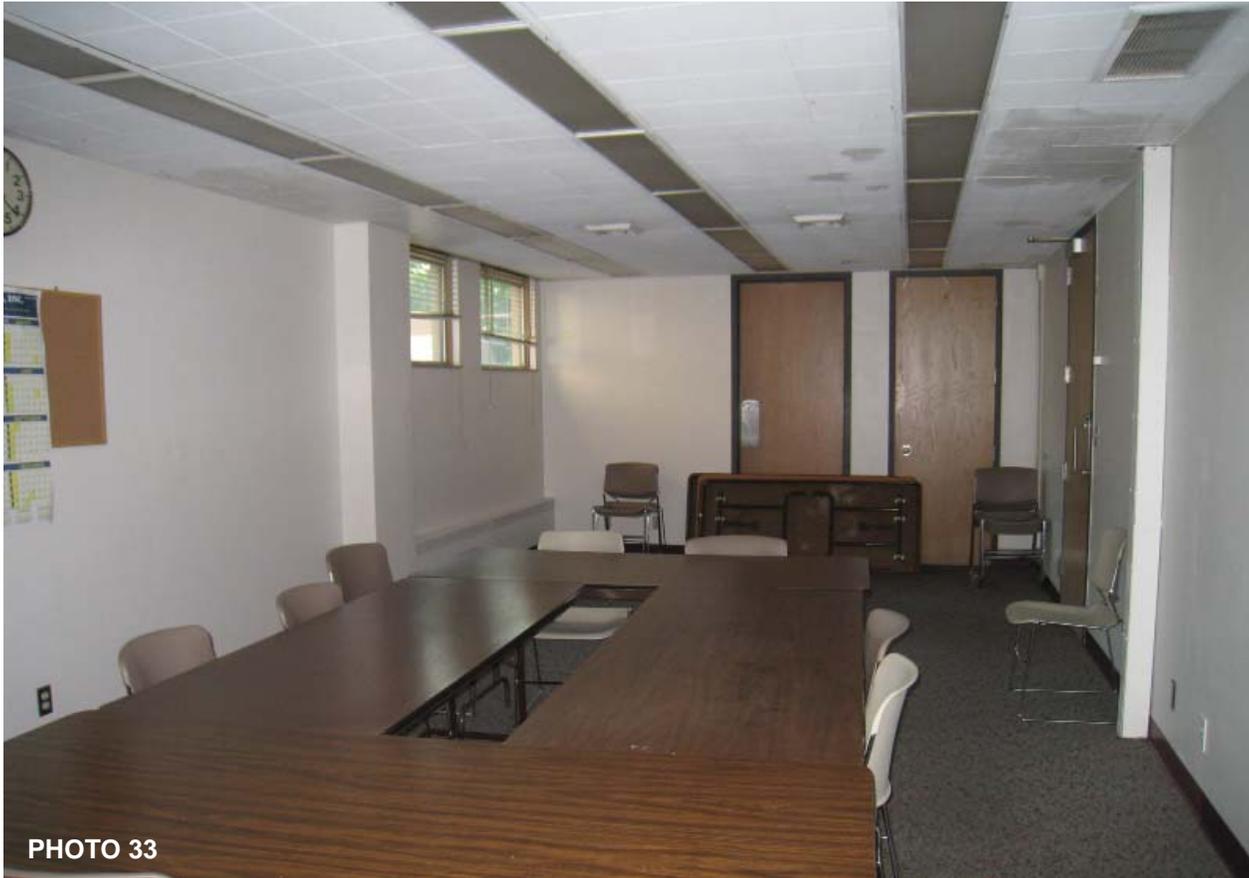
PHOTO 33

There are areas where the ceilings are stained from old water leaks (**Photo 33**). In many areas the ceilings are discolored and yellowed both from age and from the days when smoking was allowed inside the building. There is also discoloration at the areas of HVAC registers and grilles which is very common for buildings of this age.

It is recommended that all the finished ceilings throughout the building be removed and replaced with new. The removal should be completed as part of a whole building asbestos abatement project since it has been documented that asbestos fibers are contaminating the tops of many of the ceilings in the building. The ceilings should be replaced with materials that are readily available; some of the existing ceiling systems may no longer be available.

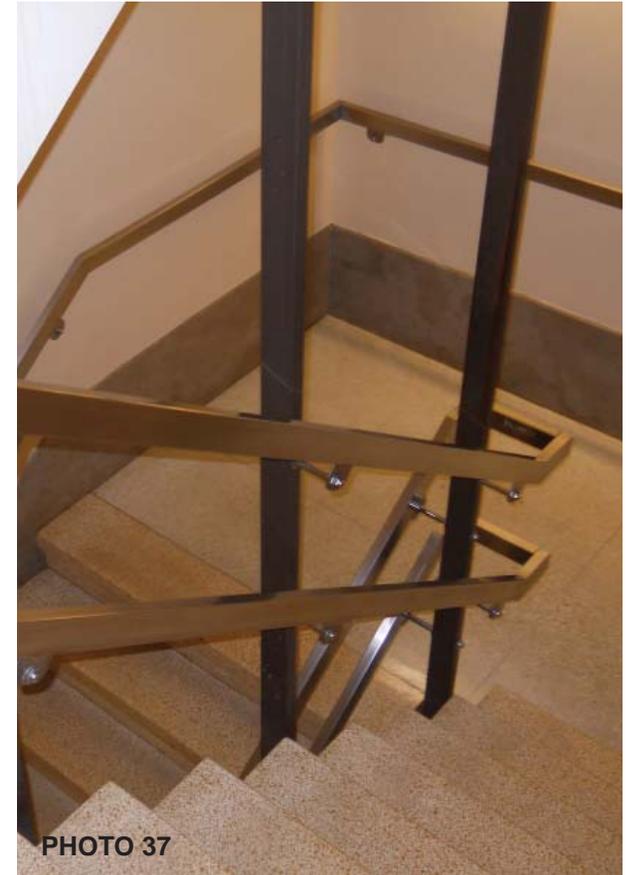
The stair structures themselves are in good condition. The main public stairs, Stair 1 and 2, both have terrazzo flooring at the landings, and the stairs themselves are constructed of precast terrazzo treads and riser system. The railings are an open stainless steel railing that does not meet current codes and need to be updated for safety reasons (**Photo 37**). This update may be as simple as adding glass guardrail panels to the existing handrail system. Glass panels have already been added to the upper landings of both stairs. The "ceilings", exposed underside of the stairs is painted but has dirt/water stains from water running over the edges when the stairs and landings are mopped. The walls have been covered with wall covers, "wall paper", which is dated and the seams are peeling away from the walls surface.

The recommendation for the stairways is to correct any safety issues and update stairs to current building codes. It is thought that this can be completed without negatively affecting the current stair aesthetic. The current non-public stairs should be evaluated as part of a building renovation design; it may be possible to reduce the number of stairways within the building since there is no longer need for "secure" stairways.

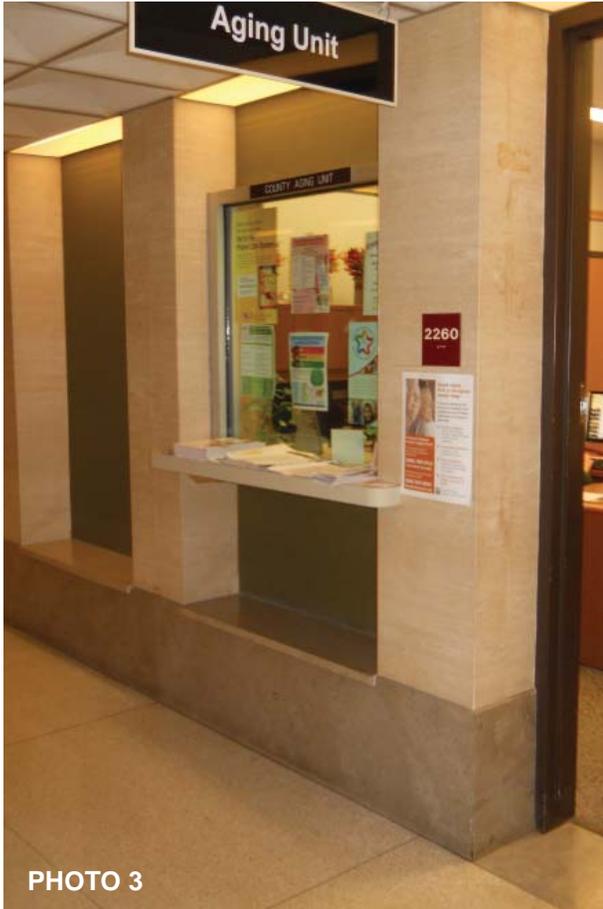
PHOTO 3

Counters, work stations, and other elements are to be provided at accessible heights and provide knee clearances and clear space for approach (**Photo 3 shows counters throughout the building do not meet accessibility requirements**).

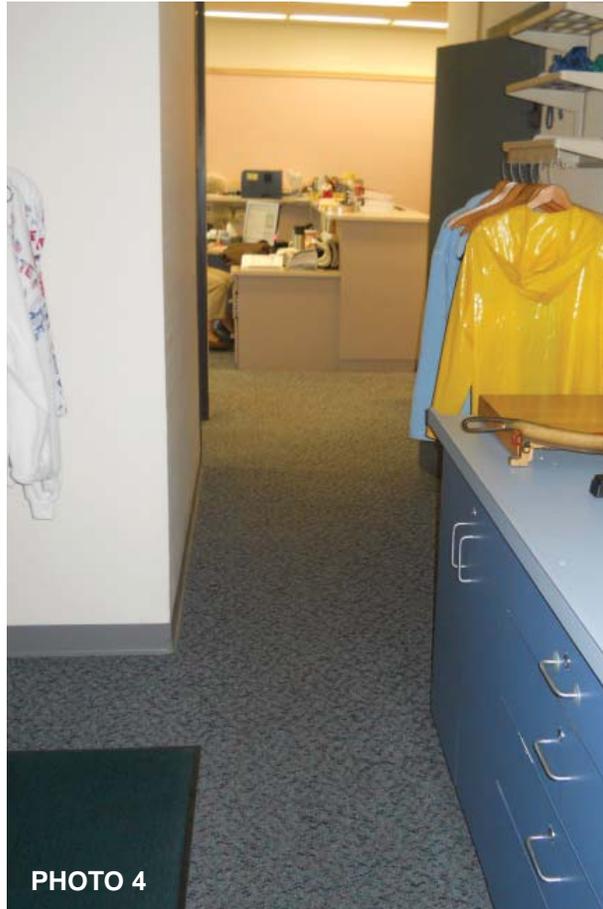
PHOTO 4

need to be accessible. The east and south entries meet this requirement. Accessible ramps and stairs require handrails on both sides. These are to be located between 34 and 38 inches off the adjacent walking surface or tread nosing and be provided with extensions measuring 12 inches at the top and the depth of the tread beyond the bottom with returns to the wall or floor. Where vertical clearance is reduced, such as under stairs, a barrier a maximum 27 inches above the floor will prevent access (**Photo 4 shows path widths that are reduced by storage below code-required widths**).

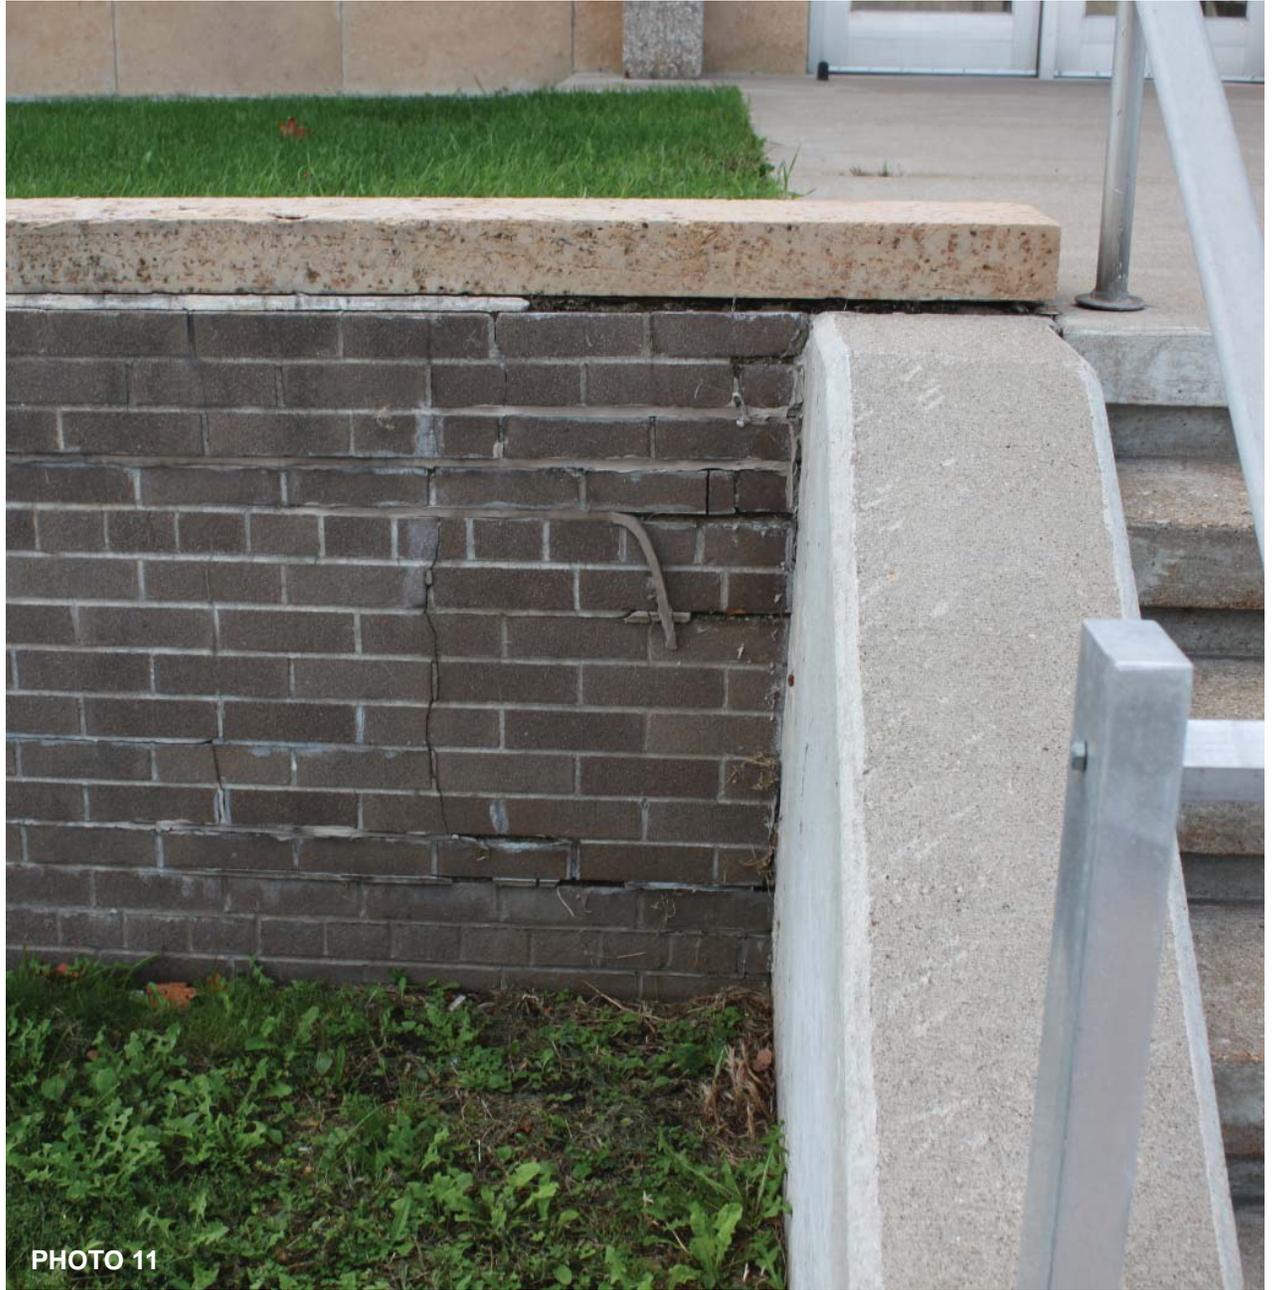
PHOTO 10

north and west has or is presently, undergoing some outward movement. The north wall has had some tie-back anchors installed. It is apparent at the northwest corner that there is outward rotation (**Photo 10**) of the west wall in an ongoing basis. These retaining walls have a significant amount of brick and joint problems due to both movement and moisture (**Photo 11**). The original drawings do not show these walls and the actual construction is unknown. This west wall could be similarly stabilized with tie-backs as a maintenance item. If complete remodeling moves forward, consideration of re-building the walls may be in order.

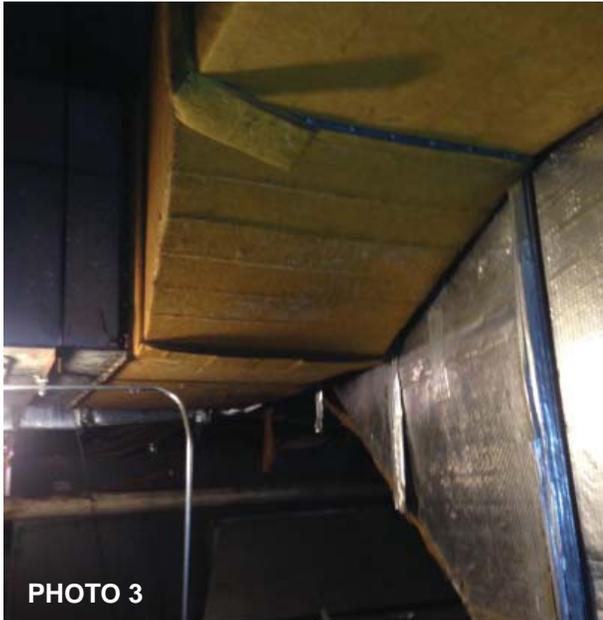
PHOTO 3

- The useful life of all air-handling units has been exceeded.
- Ductwork insulation has deteriorated and has begun to fall apart (Photos 1, 2, and 3).
- Dirt and debris line the inside of AHU-3 quite well and there are signs of rust and pitting within the unit casing.
- Access to AHU-3 is constricted and does not allow for easy service and maintenance.
- All air-handling units and the rooftop unit utilize the space above the ceiling as a return-air plenum.
- Space above the ceiling was inaccessible due to the existing asbestos conditions; however, several indicators of dirty ducts were observed (Photos 4, 5 and 6).

Upon a building renovation, the air distribution systems (air-handling units, rooftop units, exhaust fans, ductwork, piping and components) should be removed and replaced. The air distribution systems are antiquated and do not operate at the achievable efficiencies of modern technology. Additionally, there is no certainty that the existing systems will tolerate another building life cycle in their current condition.

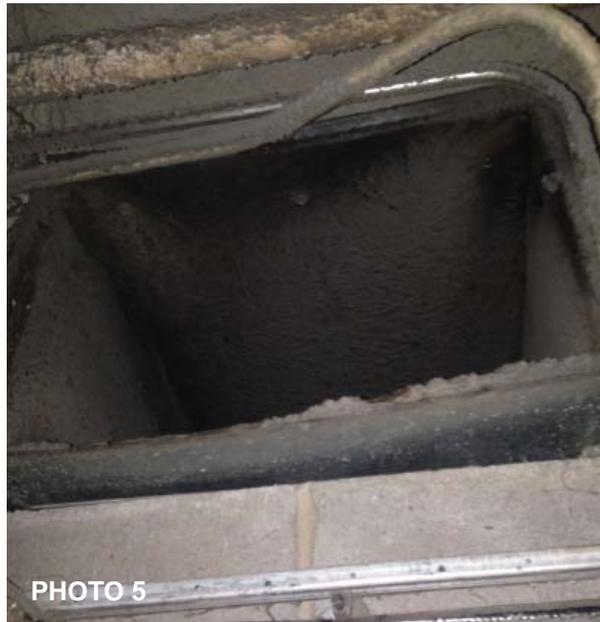
PHOTO 5

- A ceiling panel was removed such that some visual inspection above the ceiling could be achieved. As seen in Photos 5 and 6, dirt lines the surfaces of piping and ductwork above the ceiling; this space is used as a return-air plenum.

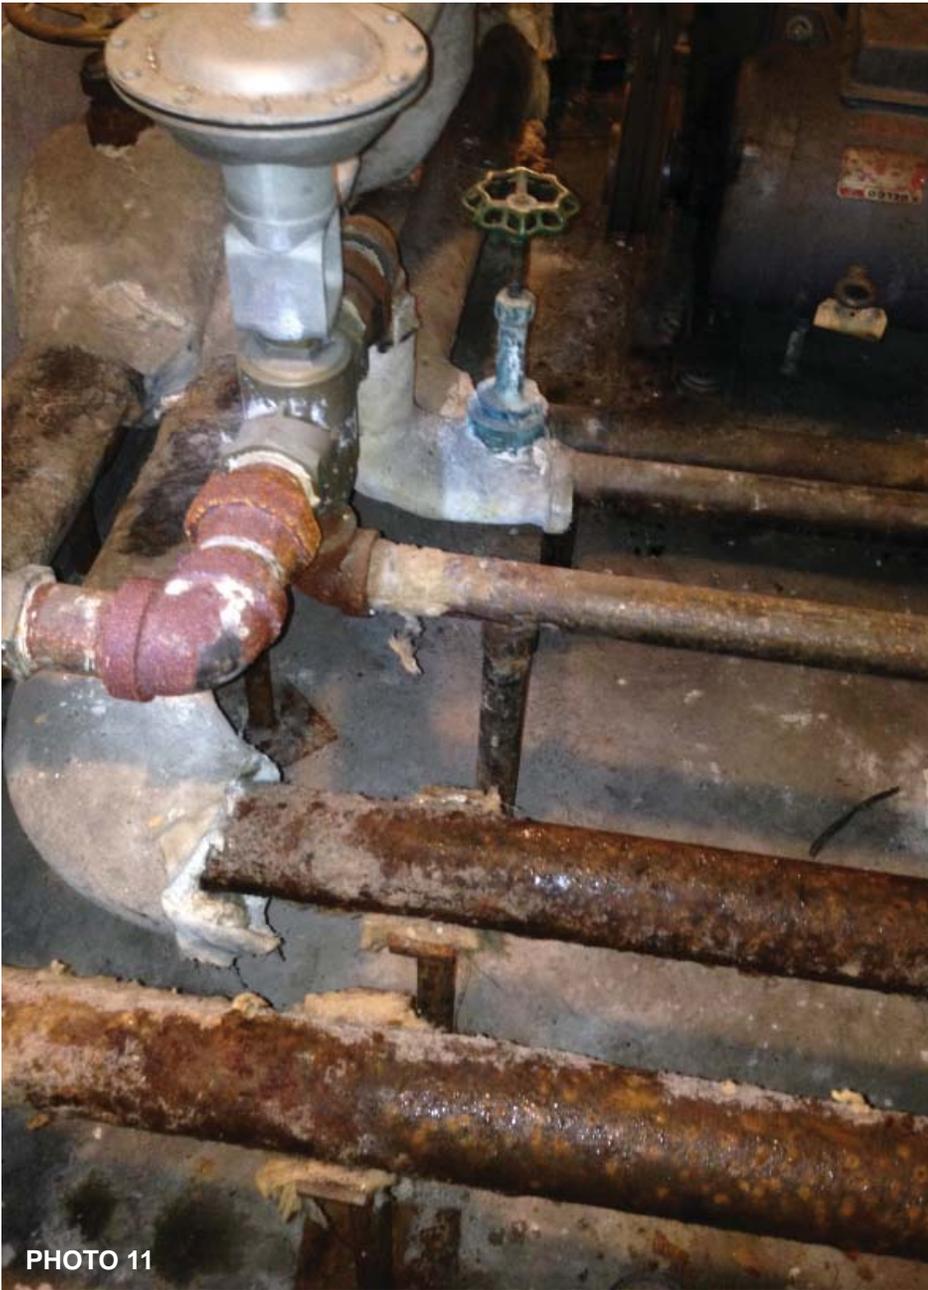
PHOTO 11

- Pipe insulation has aged and is deteriorating (Photos 9, 10, 11 and 12).
- Chilled water piping insulation has fallen off resulting in pipe sweating and oxidation (Photos 9, 10 and 11).

- Surface oxidation is a good indicator that the pipes will soon, if not already, begin breaking down with pitting and pin hole leaks.

Upon a building renovation, the entire chilled water system (i.e. piping, insulation, pumps, coils, valves and actuators, etc.) should be removed and replaced. If well water is desired or determined to be most appropriate for use in the new chilled water system, the well water should be filtered and or treated prior to entering the new chiller or other water-cooled type equipment. Regardless of future equipment selection, cupronickel heat exchangers, which are more resistant to corrosion from water with high levels of hardness and/or salinity, should be reviewed and evaluated for use.

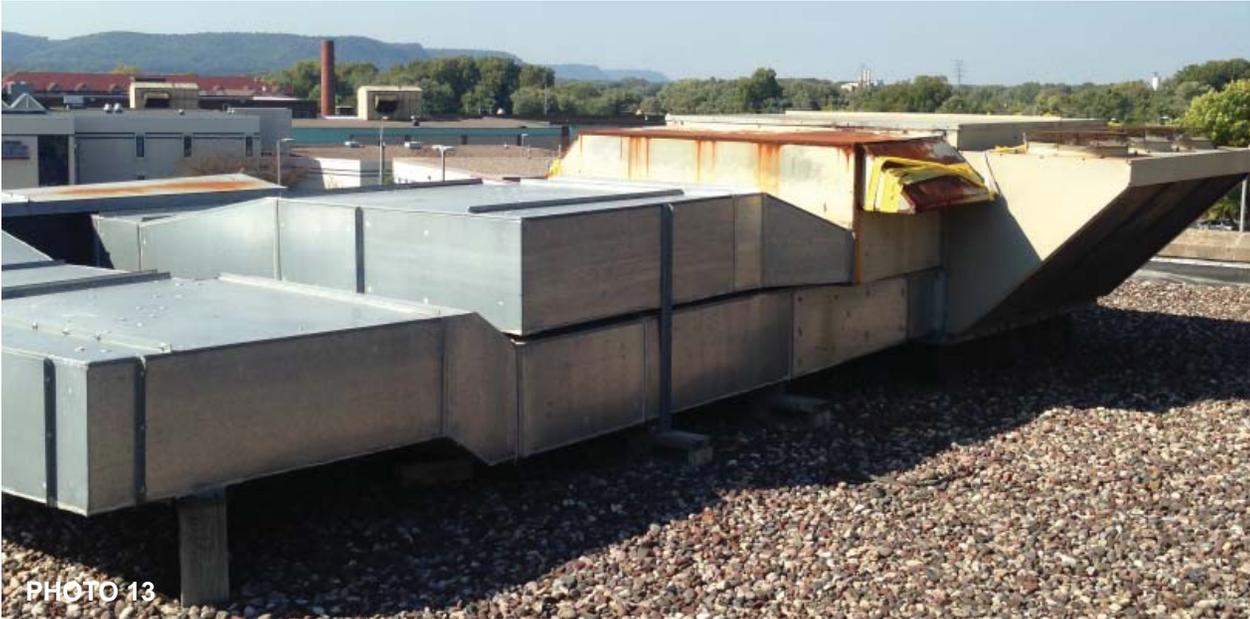
PHOTO 13

- RTU-1 (Photo 13) was installed in 1987 and has exceeded the typical life-expectancy of 20-25 years for a rooftop unit. The unit casing has a fair amount of rust and shows signs of failure and breakdown. Buildup of dirt and debris were observed on the condensing coil blocking approximately 10-15 percent of air flow (Photo 14), which de-rates the performance of the unit. Tape has been used to keep some parts intact (Photo 15). Caulking around the unit's access panels has hardened and is deteriorating (Photo 16); and several access points were observed to be loose (Photo 16).
- Considerable air leakage around the access doors and through the immediate duct connections of AHU-4 were observed (Photos 17, 18, 19 and 20).

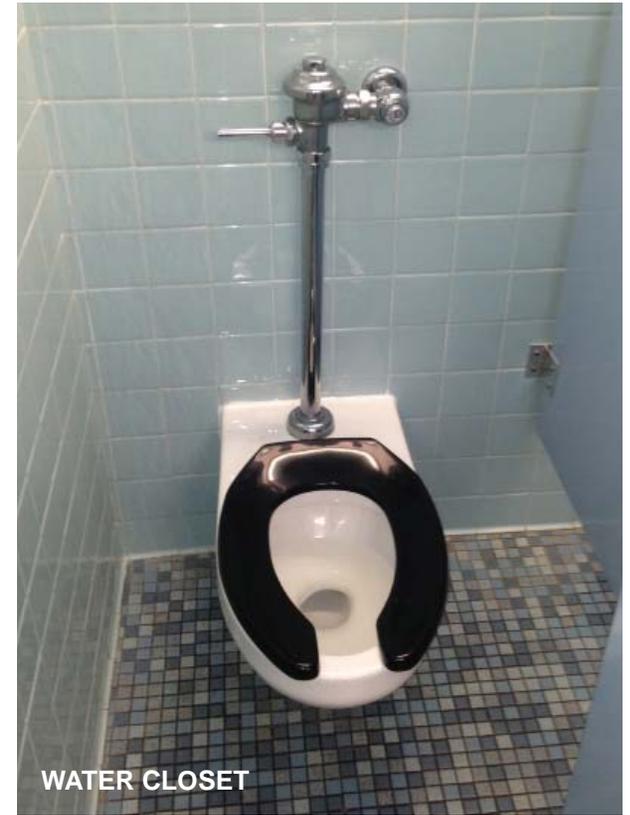
A large contributor to domestic water consumption is the type of water closets used throughout the building. Currently,

the facility has approximately thirty (30) toilets that operate with a high number of gallons per flush, which was visually determined (actual gallons per flush was not determined). The plumbing fixtures are antiquated and upon failure, replacement parts are less available. Several plumbing fixtures, such as the floor mounted urinals, do not have shut off valves and cannot be serviced without a branch, or system shutdown.

Upon a building renovation, the plumbing fixtures should be removed and replaced. Increased water efficiency should be reviewed and evaluated for water closets and urinals to realize water savings.

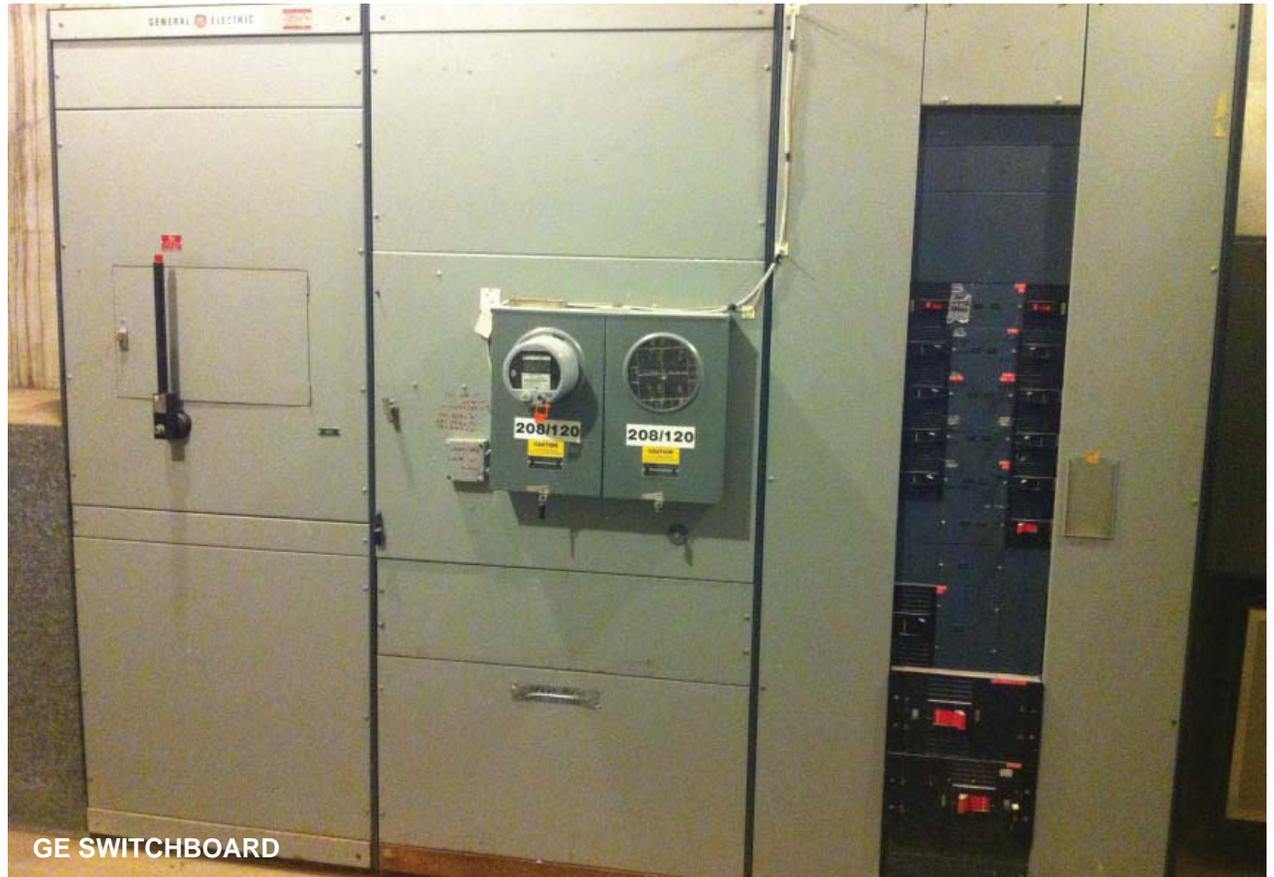
The original bolted pressure switch was manufactured by Pringle Electrical Manufacturing Company, who was purchased by Eaton Corporation approximately 10-15 years ago. These switches are still manufactured today, and if properly maintained over the course of its life should last 40 - 50 years. Bolted pressure switch maintenance consists of exercising switch and oiling linkages once a year, and cleaning parts of dirt and dust once every five years. The Pringle switch currently installed is original to the building and has reached its 50 year life span and should be replaced upon a building renovation.

The distribution section of the switchboard is group mounted circuit breakers. Roughly 80% of the mounting space is currently being taken up by existing small, medium, and large frame 3-pole circuit breakers. The remaining 20% mounting space that is available can house small frame 3-pole circuit

breakers. When switchboards get to this age they typically start having problems with potential loosening of bussing and cabling connections, rusting of enclosure structure and mounting base, continuity of enclosure ground connections, and circuit breaker malfunctioning. Circuit breaker malfunctioning issues typically seen in this age of equipment problems with tripping and resetting of the circuit breakers. What this means to the facility is extended down time, and potential personnel safety issues. The General Electric switchboard currently installed is original to the building and has reached its 50 year life span and should be replaced upon

a building renovation.

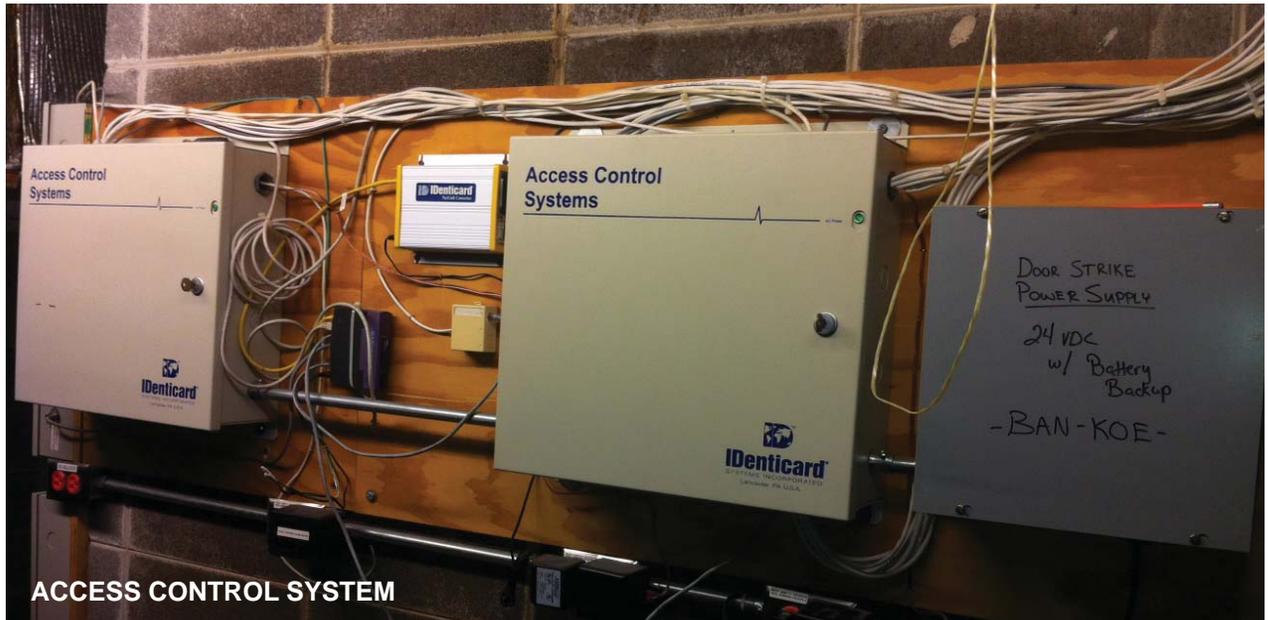
ACCESS CONTROL SYSTEM

The existing access control system currently serving the building is a web-based IDenticard System. It consists of 2 - 3 control cabinets mounted in a common closet with centralized power supplies and available slots for hardware to be added in the future to support additional card readers. System is currently monitoring HID proximity type card readers and door monitoring switches. There is currently 12 - 14 card readers deployed on this system and the wiring is installed "free air" with plenum rated cable. Upon building renovation, the existing head end equipment of the fire alarm system could be reused, however based on the age of the system full replacement of the head end equipment and field devices is recommended. Existing field devices could be placed in attic stock.

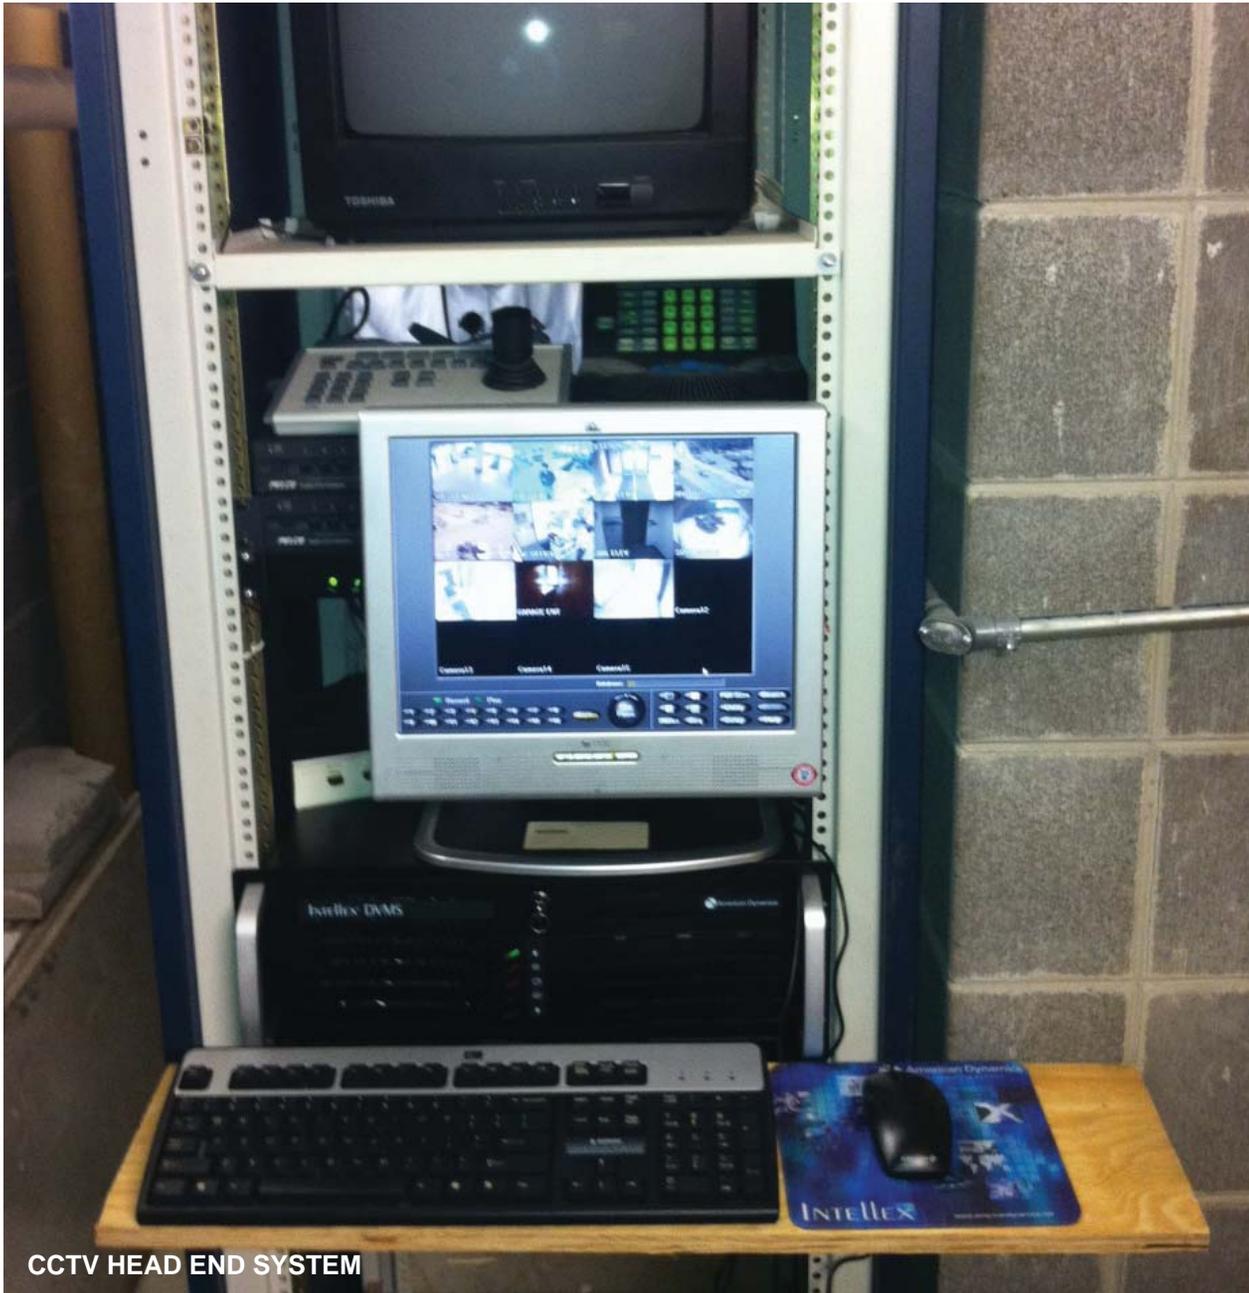
CCTV HEAD END SYSTEM

The existing CCTV system and recording equipment currently serving the building is a web-based Intellex system by Tyco with Sanyo and Pelco analog cameras. The system consists of one DVR and approximately 10 cameras. Head end system and power supplies are centralized with power and signal wiring run to each camera. The current system has some expansion capabilities and additional unused client licenses. Upon building renovation, the existing head end equipment of the CCTV system could be reused, however based on the age of the system full replacement of the head end equipment and field devices is recommended. Existing field devices could be placed in attic stock.
