LA CROSSE COUNTY ADMINISTRATIVE CENTER

SPACE NEEDS STUDY

NOVEMBER 22, 2013
FINAL REPORT

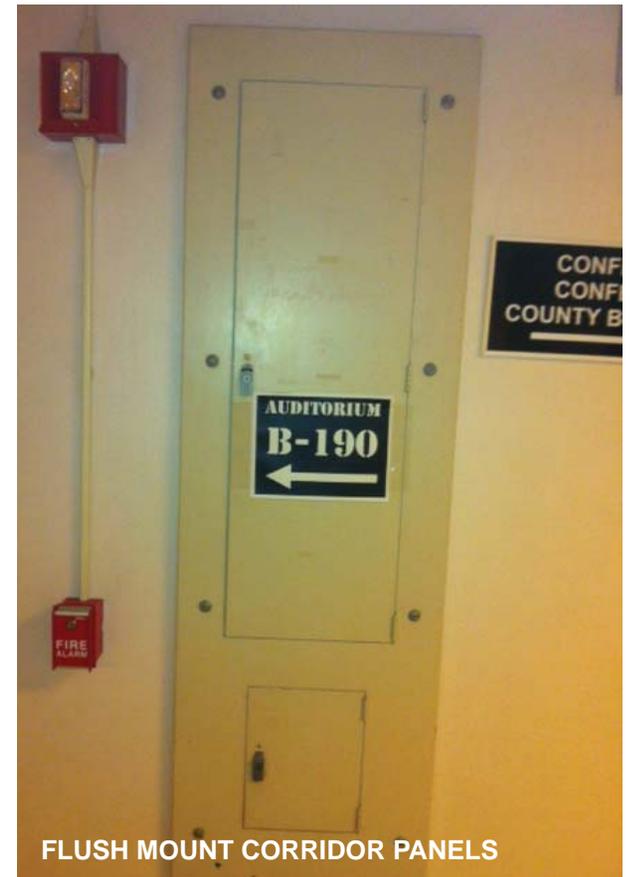
FLUSH MOUNT CORRIDOR PANELS

Power distribution throughout the facility consists of remote mounted 225Amp and 100Amp, 208/120V 3-phase, 4-wire, main lug only circuit breaker panelboards. The majority of these panels are recessed in the corridor walls on each floor for serving the lighting and receptacle loads. Typical life expectancy of electrical circuit breaker panelboards is around 40 - 45 years assuming there have been no issues to date and yearly exercising of circuit breakers has been completed. The same tripping and resetting issues of the circuit breakers apply to the panelboards too, as well as potential arc flash concerns

with having electrical panels located public corridors. The General Electric panelboards currently installed are original to the building and has surpassed their 40 -45 year life span and should be replaced upon a building renovation.
