## U. S. PUBLIC LAND SURVEY MONUMENT RECORD

SECTION 21 T 16 N, R 6 W, TOWN OF BARRE  
LA CROSSE COUNTY

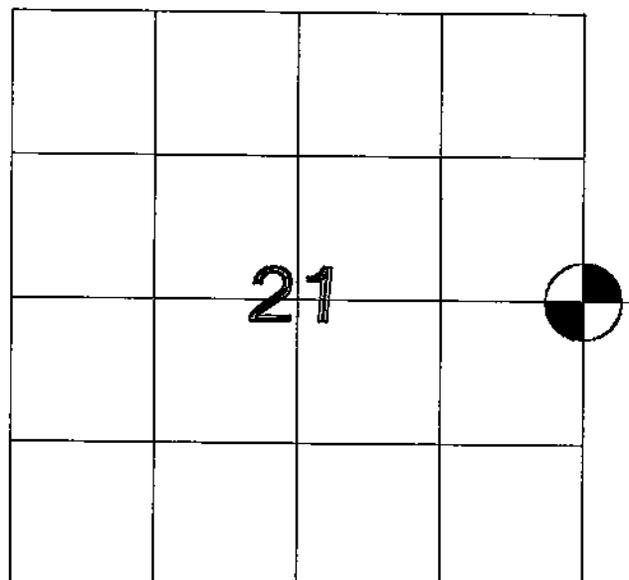
LOCATION OF LANDMARK

We found an iron pipe near the northeast corner of the SE 1/4 - NE 1/4 and projected a line through said pipe creating an equal distance split between the NE and SE corners. This area had been bulldozed and no evidence remains of the original corner.

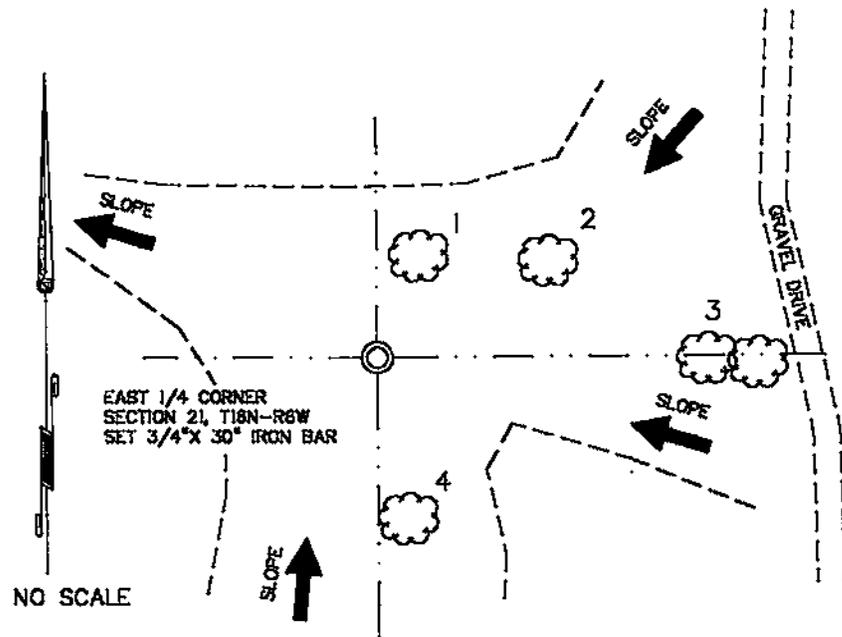
PLAN VIEW DRAWING OF REFERENCE TIES

NO	DESCRIPTION	BEARING	DISTANCE
1	P.K. NAIL IN 24" SILVER MAPLE	N 23°00'13" E	36.97'
2	P.K. NAIL IN 20" SILVER MAPLE	N 60°56'25" E	66.23'
3	P.K. IN 18" & 24" DOUBLE SILVER MAPLE	S 89°34'32" E	110.91'
4	P.K. NAIL IN 12" BURR OAK	S 11°14'17" E	54.93'
