U. S. PUBLIC LAND SURVEY MONUMENT RECORD

SECTION 3 T 17 N, R 6 W, TOWN OF Hamilton

LA CROSSE COUNTY

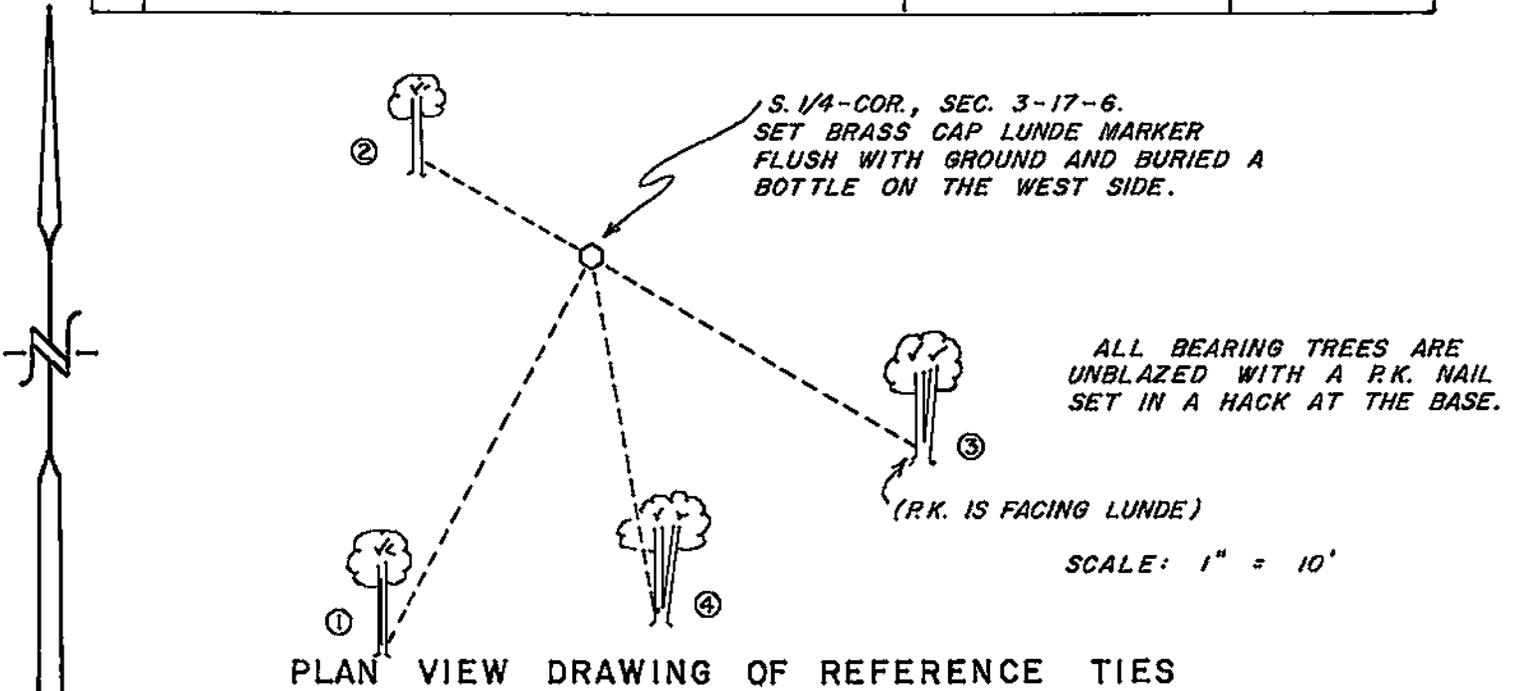
RECORD OF DURABLE WITNESS MONUMENTS

NO	DESCRIPTION	MAGNETIC	
		BEARING	DISTANCE
1	Set P.K. Nail in E.-side 6" Hickory	S 28° W	22.81 Ft.
2	Set P.K. Nail in S.-side 7" Walnut?	N 61° W	10.19 Ft.
3	Set P.K. Nail in N.W.-side 4" dbl. W. Oak	S 60° E	19.38 Ft.
4	Set P.K. Nail in W.-side dbl. Bl. Oak	S 10° E	18.64 Ft.

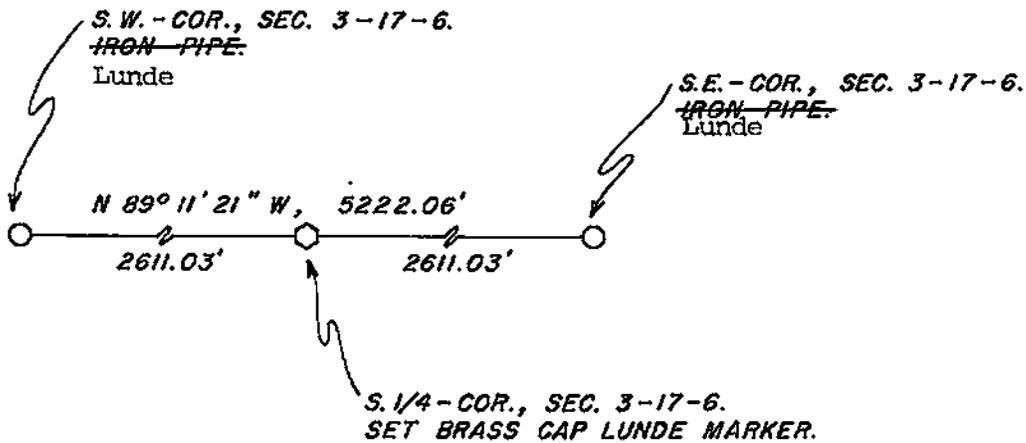
MAP SHOWING DISTANCE AND DIRECTION TO OTHER PUBLIC LAND SURVEY CORNERS USED FOR REESTABLISHING THE CORNER

(not to scale)

I set this corner by single proportionate measurement. The computed corner does not fit the occupied corner as it falls 87' South of it. I followed the old line fence 1/2 mile to the West of the occupied corner. The first 1/4 mile appeared to be fairly straight, well maintained over the years, and very old as the wire went through the middle of old white oaks. It was obviously an "ancient" fence. The second 1/4 mile, which started from a well maintained (3) way fence corner with three tie posts, was not as well maintained, and meanders somewhat as it goes up and over the bluff. A study of the USGS map and Describe or show any material discrepancy between the location of the restored corner and that of the corner previously restored or reestablished.
