U. S. PUBLIC LAND SURVEY MONUMENT RECORD

SECTION 21 T 17 N, R 6 W, TOWN OF HAMILTON

LA CROSSE COUNTY

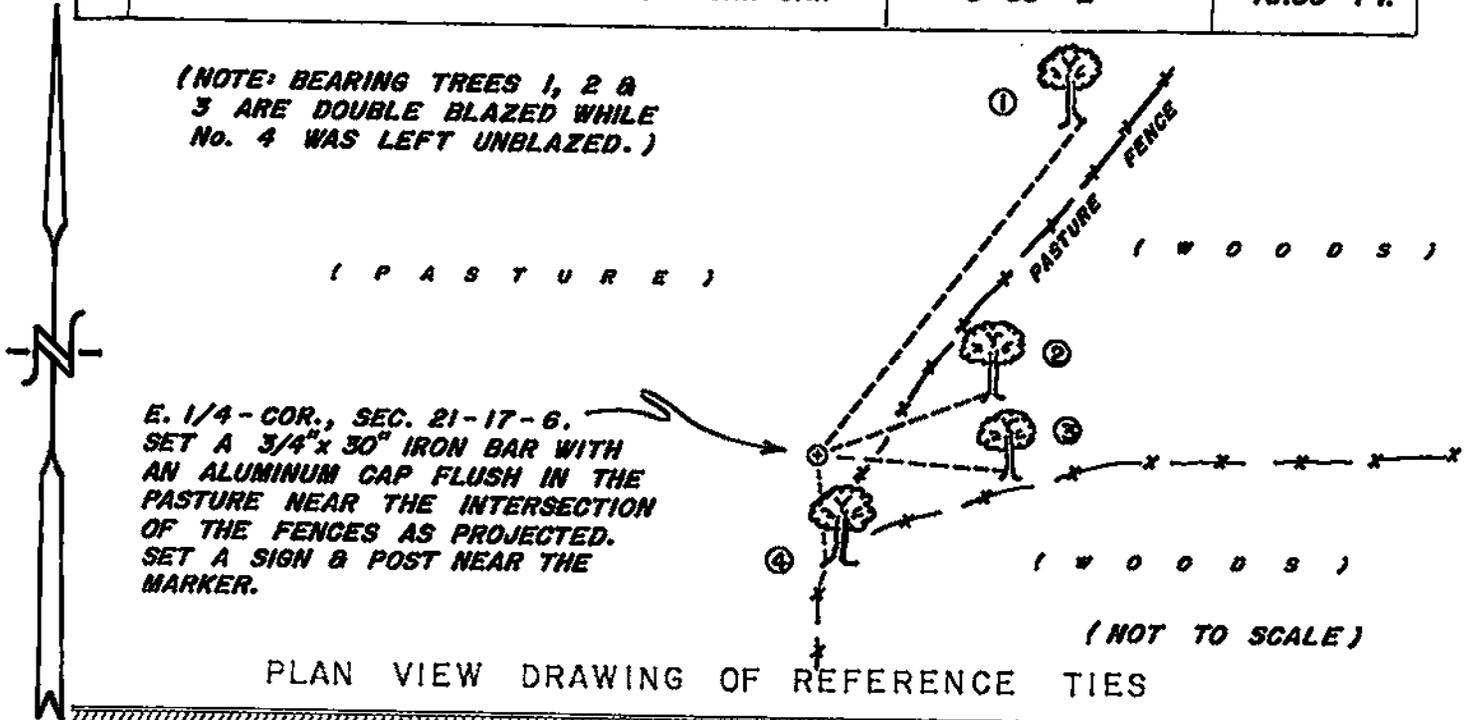
NO	DESCRIPTION	MAGNETIC	
		BEARING	DISTANCE
1	SET A NAIL IN S.E.-SIDE OF A 12 1/2" HICKORY	N 38° E	60.97 FT.
2	SET A NAIL IN S.E.-SIDE OF A 13 1/2" BURR OAK	N 70° E	27.99 FT.
3	SET A NAIL IN S.-SIDE OF A 10" WHITE OAK	S 86° E	29.33 FT.
4	SET A NAIL IN S.W.-SIDE OF A 24 1/2" BURR OAK	S 05° E	16.50 FT.

(NOTE: BEARING TREES 1, 2 & 3 ARE DOUBLE BLAZED WHILE No. 4 WAS LEFT UNBLAZED.)

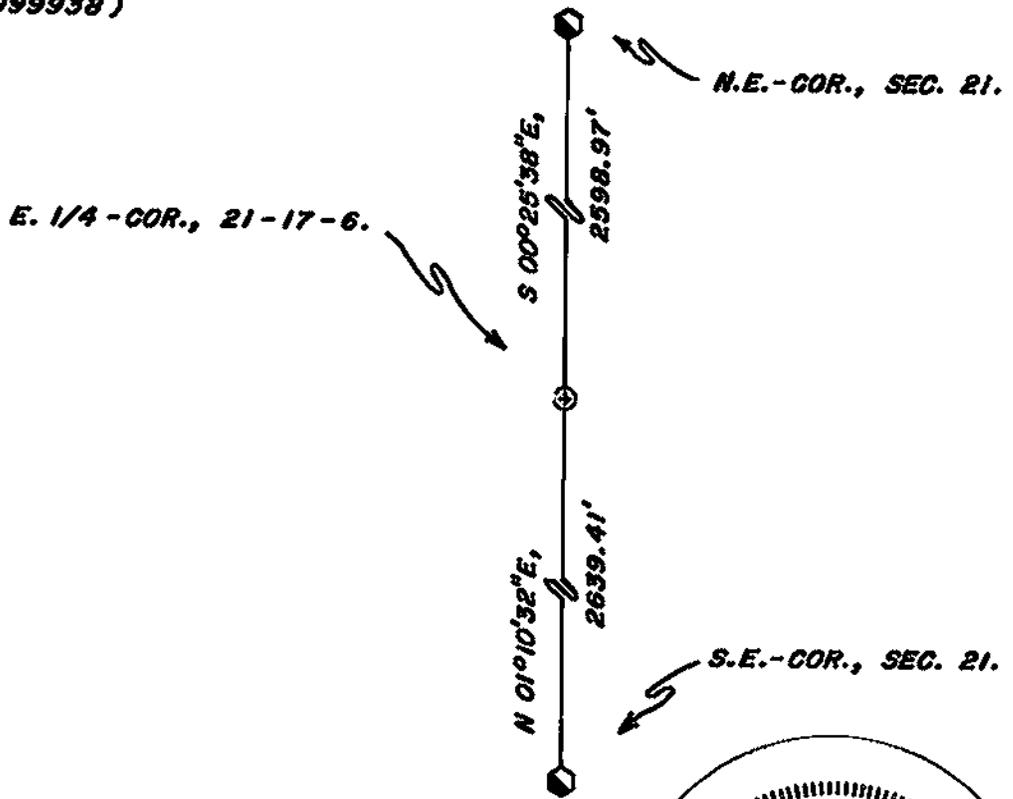
MAP SHOWING DISTANCE AND DIRECTION TO OTHER PUBLIC LAND SURVEY CORNERS USED FOR REESTABLISHING THE CORNER

(GRID BEARINGS AND DISTANCES)
 (GRID FACTOR: 0.999938)
 (NOT TO SCALE)
