U. S. PUBLIC LAND SURVEY MONUMENT RECORD

SECTION 11 T 17 N, R 8 W, TOWN OF HOLLAND

LA CROSSE COUNTY

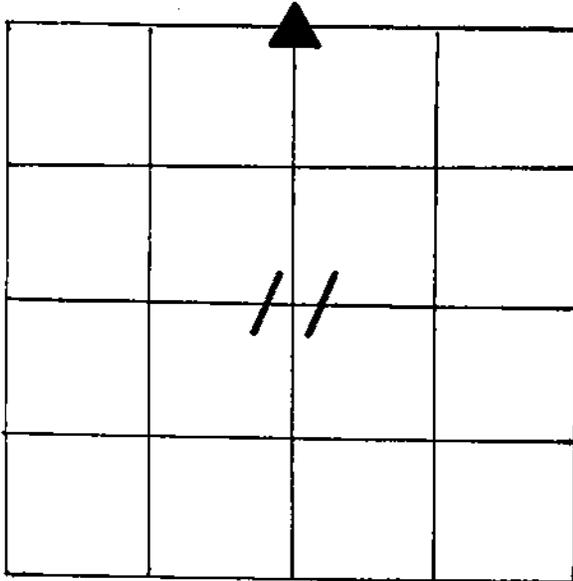
LOCATION OF LANDMARK

WISCONSIN COORDINATE SYSTEM	
North	<i>720,795.089</i>
East	<i>1,626,078.971</i>
Theta Angle	
Horiz. Order	
Vert. Order	
DATUM:	<i>1983('91)</i>
TYPE OF LANDMARK	
<i>RAILROAD SPIKE IN PAVEMENT.</i>	
BEARINGS ARE REFERENCED TO	
<i>GRID NORTH AS PER SECTION DATA.</i>

Our old Berntsen marker was destroyed during highway construction last year(2004)
 We set a railroad spike at the old corner location after the highway was rebuilt.

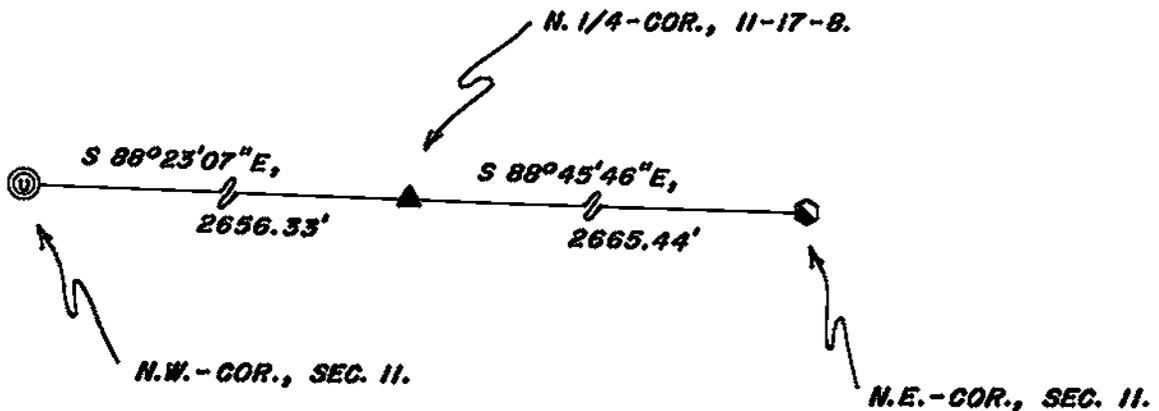
MAP SHOWING DISTANCE AND DIRECTION TO OTHER PUBLIC LAND SURVEY CORNERS USED FOR REESTABLISHING THE CORNER

(GRID BEARINGS AND DISTANCES)
(GRID FACTOR: 0.9999433)
(NOT TO SCALE)

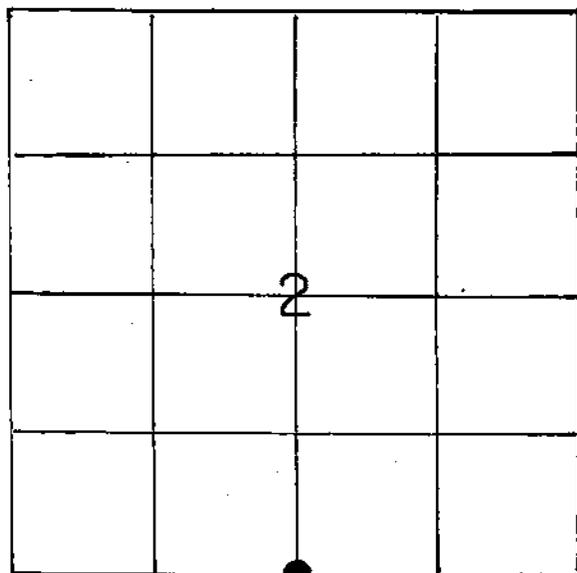
LOCATION OF LANDMARK

I found an iron bar at the corner. This bar has been used as the corner in previous surveys. I accepted this bar as the best available evidence of the original government corner position, removed it, and replaced it with a 14" long Berntsen top, down 1/2" or so.

WISCONSIN COORDINATE SYSTEM	
North	720,796.929
East	1,657,603.449
Theta Angle	
Horiz. Order	
Vert. Order	
TYPE OF LANDMARK	
Berntsen top	
BEARINGS ARE REFERENCED TO	
Grid

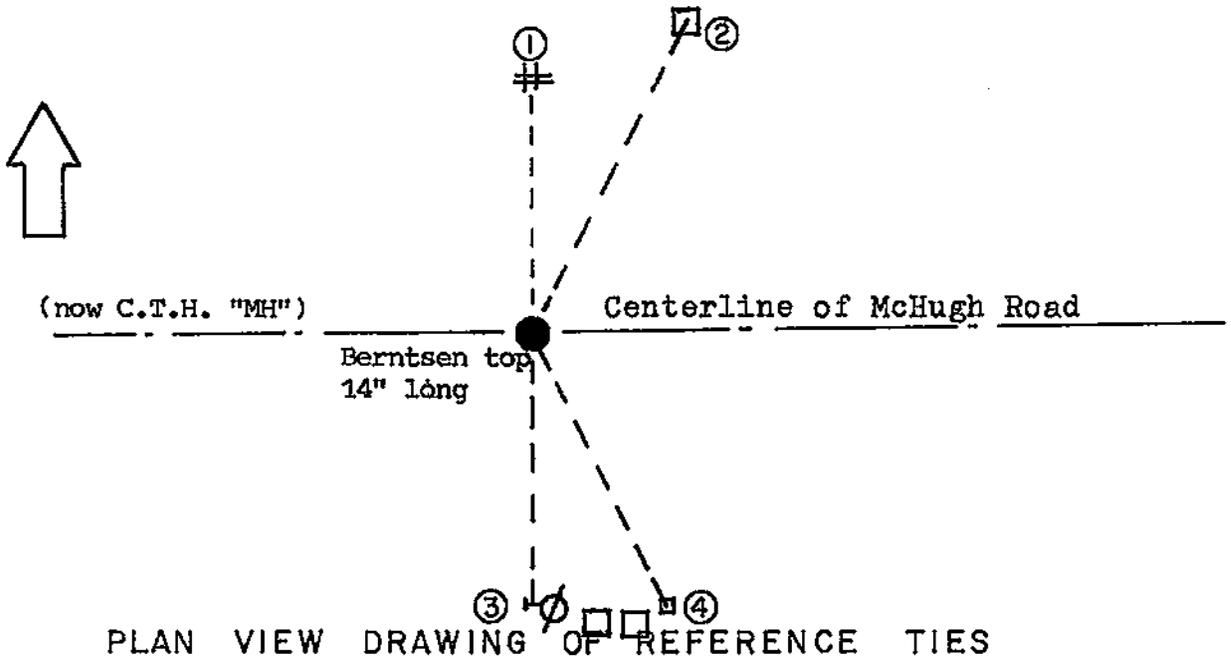
RECORD OF DURABLE WITNESS MONUMENTS

NO	DESCRIPTION	BEARING	DISTANCE
1	Existing iron pipe	North \pm	25.00
2	To the center of a telephone box	-----	37.70
3	To a P.K. nail in a power pole	South \pm	34.27
4	To the center of a telephone box	-----	37.60
