U. S. PUBLIC LAND SURVEY MONUMENT RECORD

SECTION 1 T 17 N, R 8 W, TOWN OF HOLLAND

LA CROSSE COUNTY

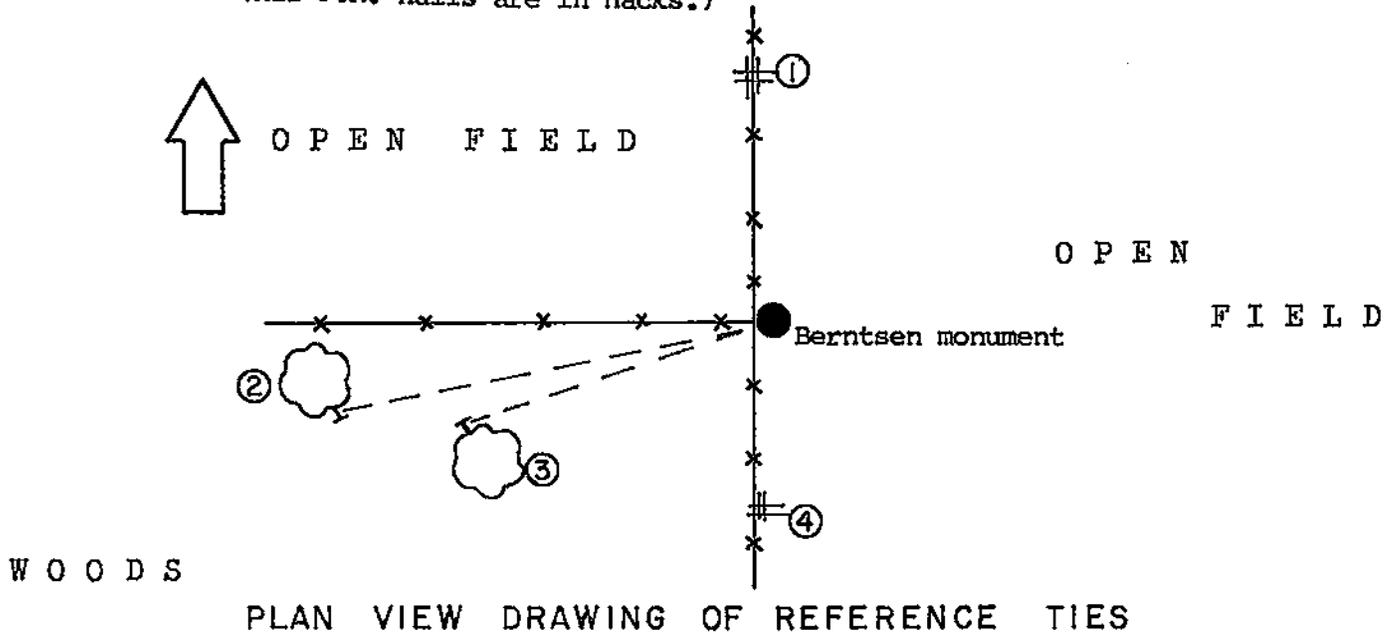
PLAN VIEW DRAWING OF REFERENCE TIES

RECORD OF DURABLE WITNESS MONUMENTS

| NO | DESCRIPTION | BEARING | DISTANCE |
|---|---|---|---|
| 1 | Set a 1½" iron pipe | North± | 31.75 |
| 2 | P.K. nail in a double blazed 10" Burr oak | Magnetic = S86°W | 34.96 |
| 3 | P.K. nail in a double blazed 9" Burr oak | Magnetic = S72°W | 19.40 |
| 4 | Set a 1½" iron pipe | South± | 15.01 |

(All P.K. nails are in hacks.)

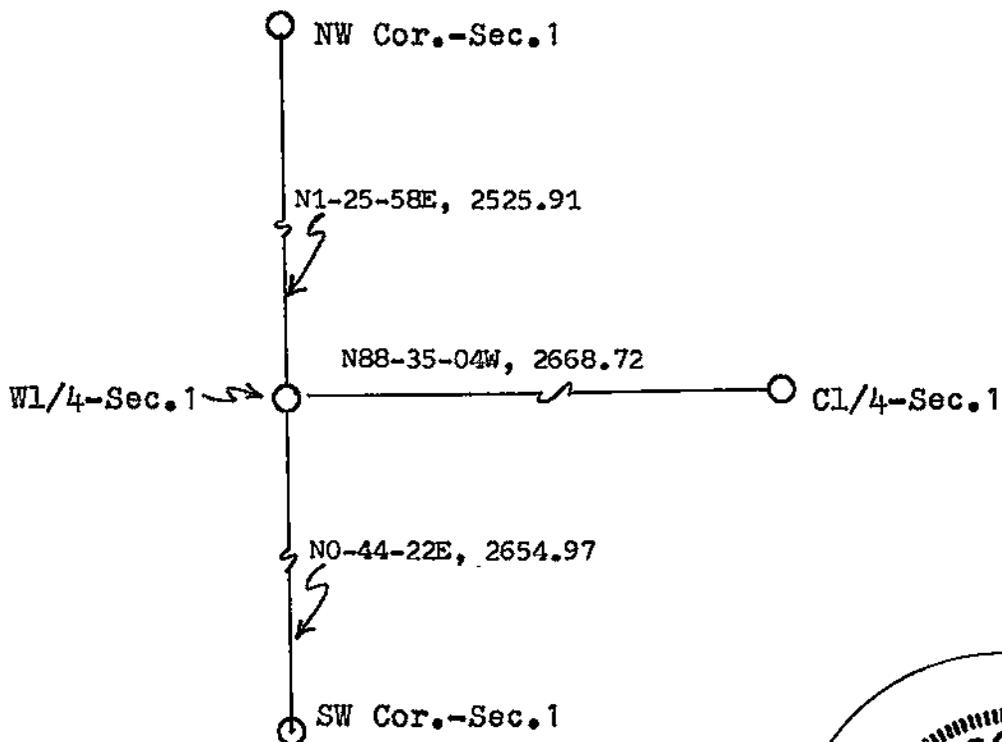
MAP SHOWING DISTANCE AND DIRECTION TO OTHER PUBLIC LAND SURVEY CORNERS USED FOR REESTABLISHING THE CORNER

(not to scale)
Grid bearings and distances
