U. S. PUBLIC LAND SURVEY MONUMENT RECORD

SECTION 36 T 18 N, R 8 W, TOWN OF HOLLAND
 LA CROSSE COUNTY

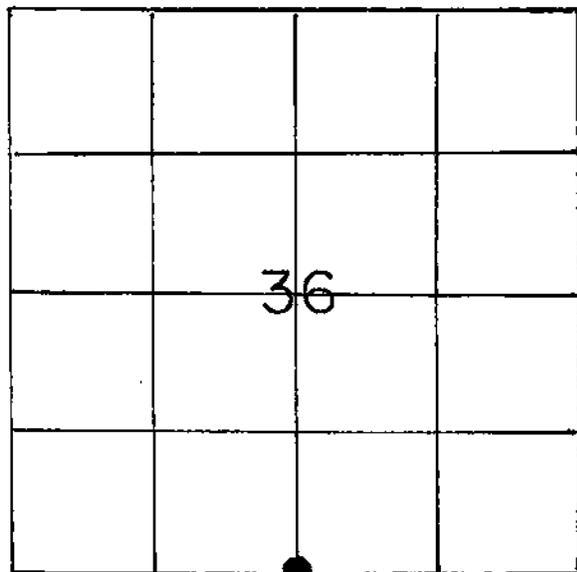
LOCATION OF LANDMARK

South Zone	
WISCONSIN COORDINATE SYSTEM	
North	725,878.241
East	1,663,007.055
Theta Angle	
Horiz. Order	
Vert. Order	
TYPE OF LANDMARK	
Berntsen Monument Railroad Spike	
BEARINGS ARE REFERENCED TO	
Grid

I found a P.K. nail at the occupied corner. This location has been used as the corner in previous surveys. I accepted this position as the best available evidence of the original government corner location. I removed the P.K. nail and replaced it with a Berntsen monument, down 1/2" with P.K. nails 1' West and 1' South.

Part of the Berntsen was destroyed during road repaving. A railroad was set over the remnants. spike ↗

NO	DESCRIPTION	BEARING	DISTANCE
1	To a P.K. nail in a 11" double blazed Norway	-----	58.44
2	Set an iron pipe	North \pm	24.73
3	Existing iron pipe	South \pm	24.74
4	To a P.K. nail in an unblazed 14" Norway	-----	59.64
