U. S. PUBLIC LAND SURVEY MONUMENT RECORD

SECTION 22 T 16 N, R 6 W, TOWN OF BARRE

LA CROSSE COUNTY

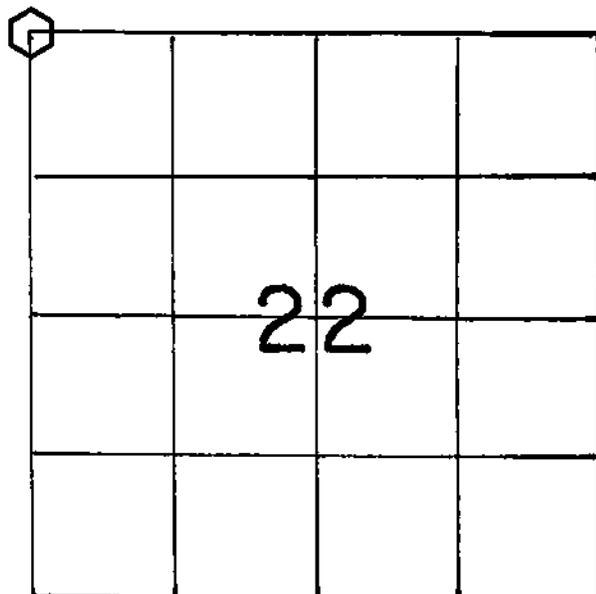
LOCATION OF LANDMARK

Brass cap Lunde marker.

Derald Kading shows an existing iron pipe at this corner in April of 1979. Ray Pelishek calls for a County Survey Marker at this corner in October of 1979. I found a Berntsen marker at the corner. It fits the occupied conditions very well. The Berntsen had been "heaved up" by frost and hit by a snowplow. I replaced the Berntsen with a brass capped Lunde marker.

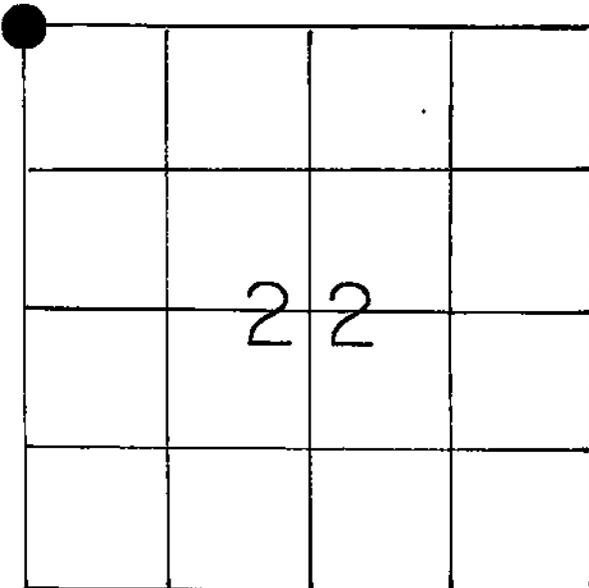
LOCATION OF LANDMARK

Derald Kading shows an existing iron pipe at this corner in April of 1979. Ray Pelishek calls for a County Survey Marker at this corner in October of 1979. I found a Berntsen marker at the corner. It fits the occupied conditions very well.

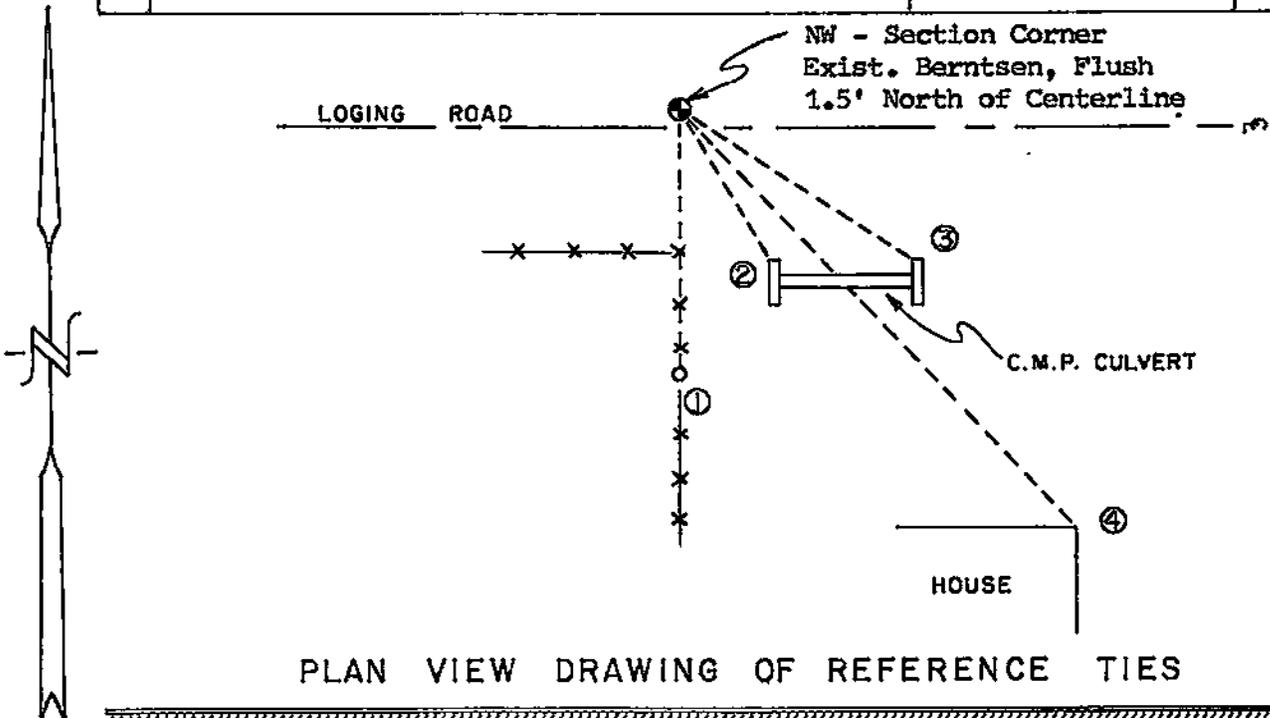
PLAN VIEW DRAWING OF REFERENCE TIES

NO	DESCRIPTION	BEARING	DISTANCE
1	EXIST. IRON PIPE INSIDE A 2" IRON PIPE	SOUTH ±	33.00 Ft.
2	NORTHWEST CORNER OF WESTERLY CULVERT WALL	S 30 E ±	19.00 Ft.
3	NORTHWEST CORNER OF EASTERLY CULVERT WALL	S 60 E ±	37.29 Ft.
4	NORTHEAST CORNER OF EXISTING HOUSE	S 40 E ±	128.67 Ft.

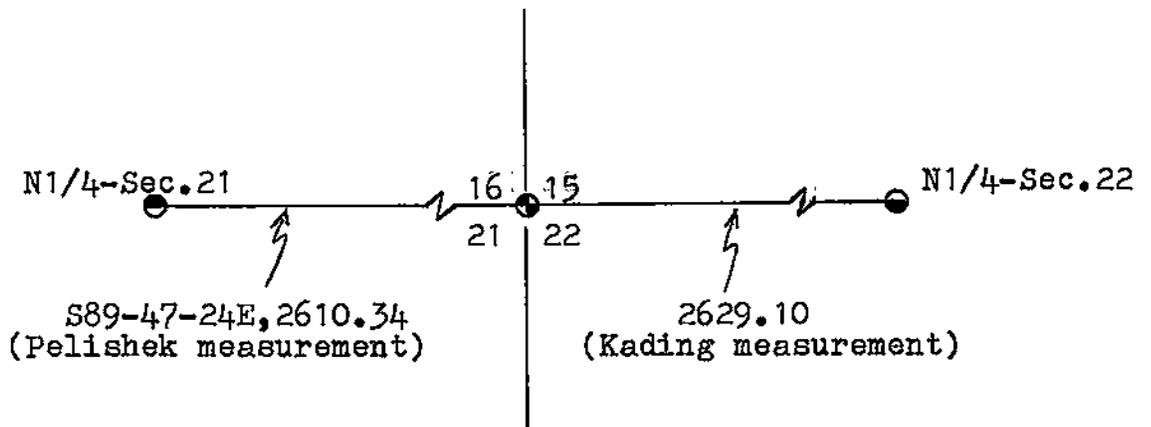
MAP SHOWING DISTANCE AND DIRECTION TO OTHER PUBLIC LAND SURVEY CORNERS USED FOR REESTABLISHING THE CORNER

(NOT TO SCALE)
