U. S. PUBLIC LAND SURVEY MONUMENT RECORD

SECTION 4 T 16 N, R 6 W, ^{Village} ~~TOWN~~ OF West Salem

LA CROSSE COUNTY

SECTION 4 T 16 N, R 6 W, TOWN OF HAMILTON

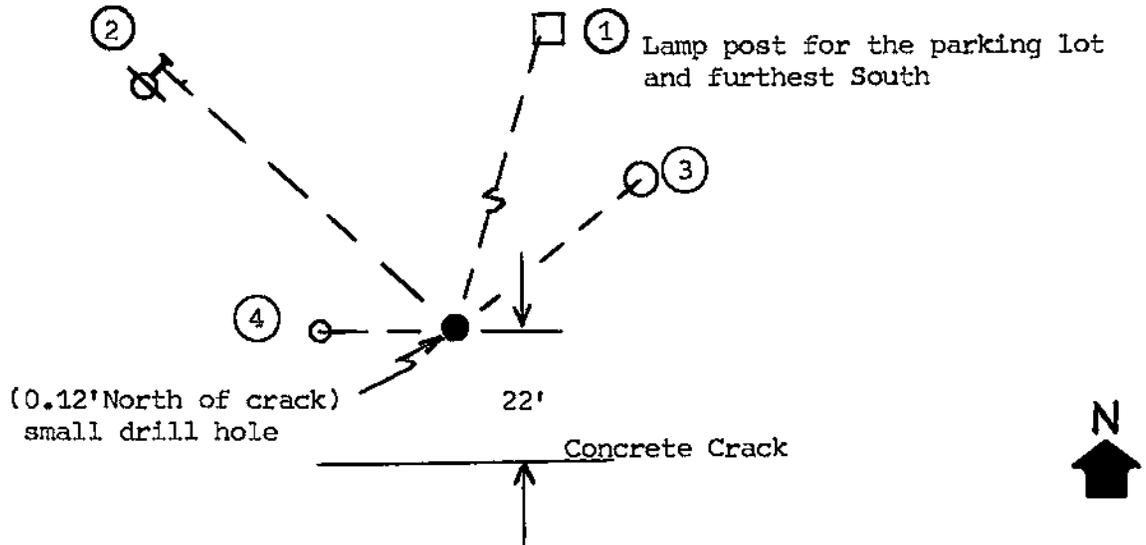
PLAN VIEW DRAWING OF REFERENCE TIES

The P.K. nail was destroyed during road construction. The new corner falls in the concrete which chipped away as I tried to set a drill hole. There is only a small drill hole at the corner. It falls 7.06' feet East of my tie P.K. and 0.12' North of the concrete crack. The easiest way to shoot this corner is to shoot the P.K. and adjust the coordinate 7.06' East and 0.12' North.

NO	DESCRIPTION	BEARING	DISTANCE
1	Southwest bolt of lamp post	-----	110.82
2	P.K. nail in new power pole	-----	90.24
3	Center of manhole	-----	56.93
4	Set P.K. nail at the intersection	-----	7.06

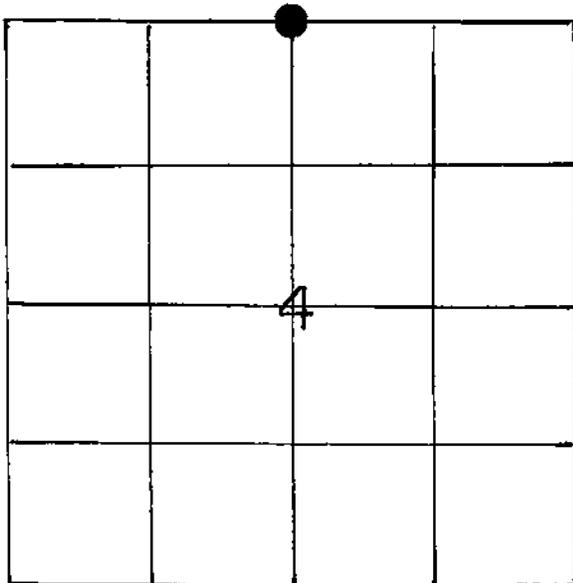
LOCATION OF LANDMARK

P.K. nail with the top broken off

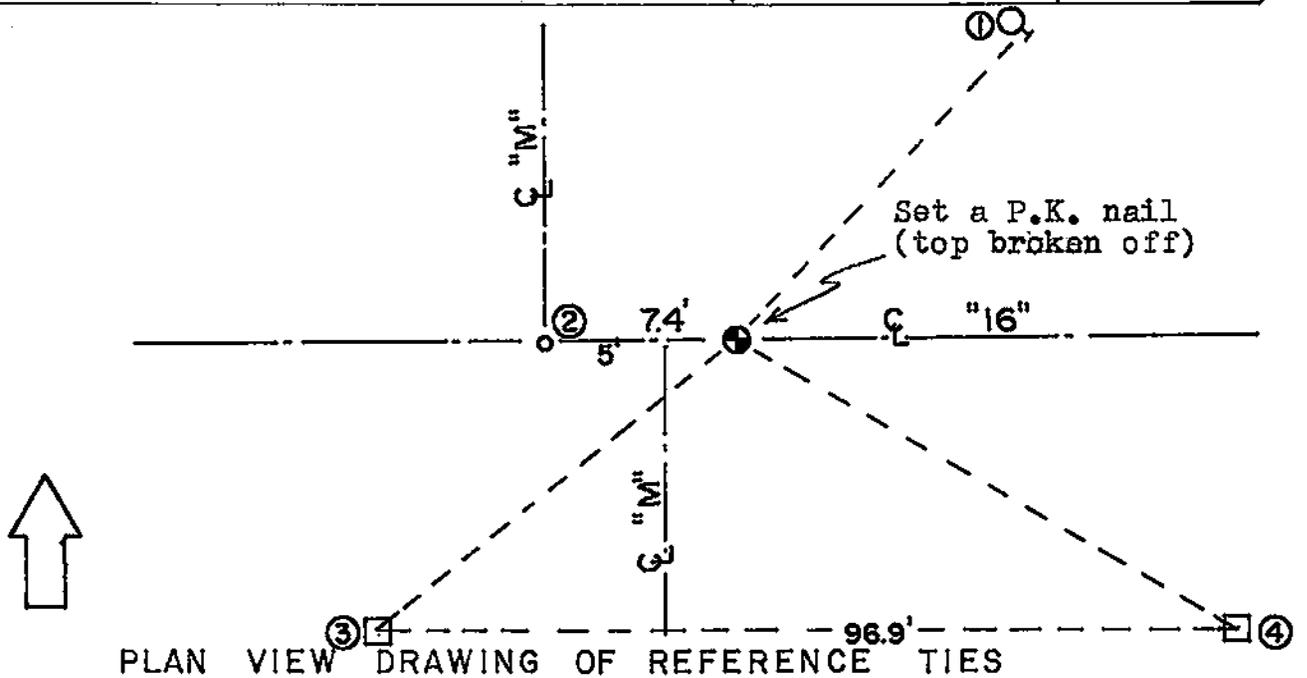
MAP SHOWING DISTANCE AND DIRECTION TO OTHER PUBLIC LAND SURVEY CORNERS USED FOR REESTABLISHING THE CORNER
(not to scale)

My research showed that this corner had at least four possible locations. My traversing and computations indicate to me that the corner should be set so as to fit the location shown on the last DOT hwy. map. I agree with the DOT on this corner. I discussed this problem with Ray Pelishek, and he agrees with my final location too. Rob Lampman used this corner in March of 1985.

I do not agree with the P.K. nail 7.4' to the West which has been used as the corner in previous surveys.

NO	DESCRIPTION	BEARING	DISTANCE
1	To a P.K. nail in a wood R/W post	- - - - -	58.49
2	Existing P.K. nail	- - - - -	7.40
3	To the middle of a steel R/W post	- - - - -	60.85
4	To the middle of the top of a steel R/W post - - - -	- - - - -	79.85
