## U. S. PUBLIC LAND SURVEY MONUMENT RECORD

SECTION 24 T 18 N, R 6 W, TOWN OF Farmington

LA CROSSE COUNTY

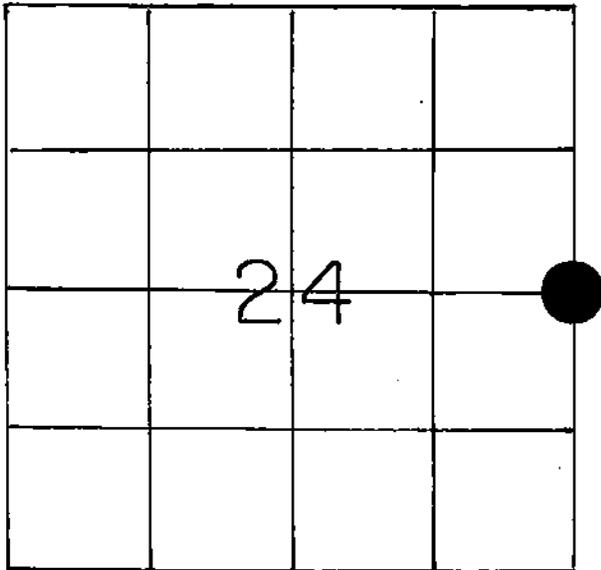
LOCATION OF LANDMARK

BRASS CAP LUNDE MARKER

Norm Hurlburt and I accepted the old occupied fence corner as the best available evidence of the original government corner position. I set a brass capped Lunde marker by the old downed fence corner. While digging, I dug up an old corner post. The corner is mounded with rocks, and a German wine bottle is buried to the South of the Lunde.
